ENGINEERING ASSESSMENT OF STRUCTURES AT THE OLD BURYING GROUND STONEHAM, MASSACHUSETTS

Cemetery	Stoneham Old Burying Ground		
Inspection Date	April 11, 2012	Inspector	Pete Culmo

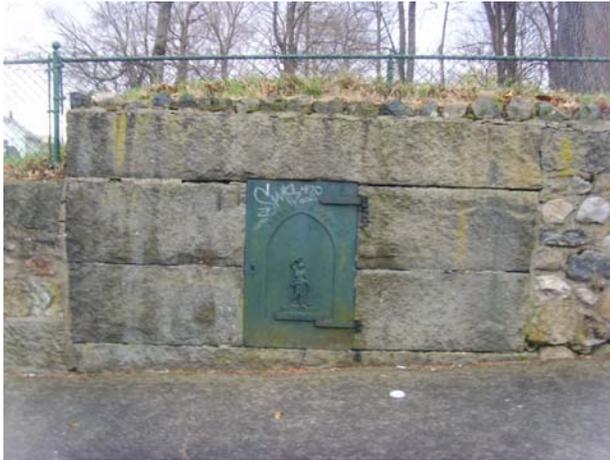
Peter Green Tomb
Dated 1855

The top stones on all three tombs have shifted toward the street. The Green Tomb has the least movement, and the Hill Tomb has the most movement. This has caused the joints to open up, which led to the re-pointing on the front façade. There are several sinkholes in the soil above the tombs. These sinkholes are located near the front wall façade.

This work need not all be done at one time. Individual tombs can be restored as monies become available. The work should start with the Hill Tomb, then the Town Tomb and finally the Green Tomb. This is based on the relative amount of movement of the front façade.

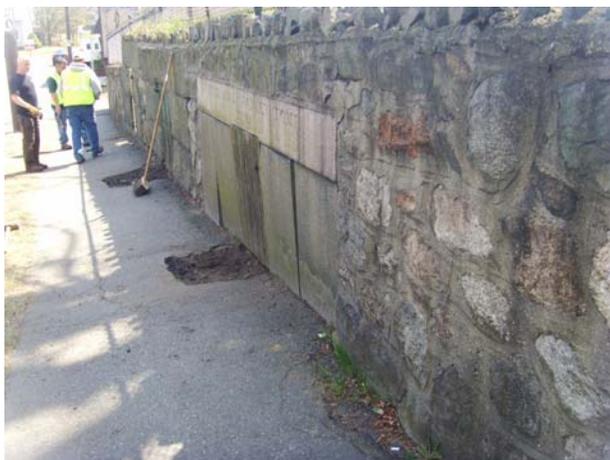
James Hill’s Family Tomb
Dated 1836

The Hill tomb has a wooden door that is not hinged. It is not original. A wooden door matching the size of the opening was found inside the tomb. It is not known if this is the original door. Based on the longevity of a typical wood door, this door may also not be the original door. It at least predates the current door. The other tombs have iron doors with iron hinges. The Green Tomb has an ornate casting within the door panel. We suspect that this is the original door, since it is dated. The Town Tomb has a historically accurate recessed panel design. It is most likely the original door.

The original door on the Hill Tomb may have been wood. A replacement door could be made of wood, or an iron door can be fabricated that is consistent with period doors.

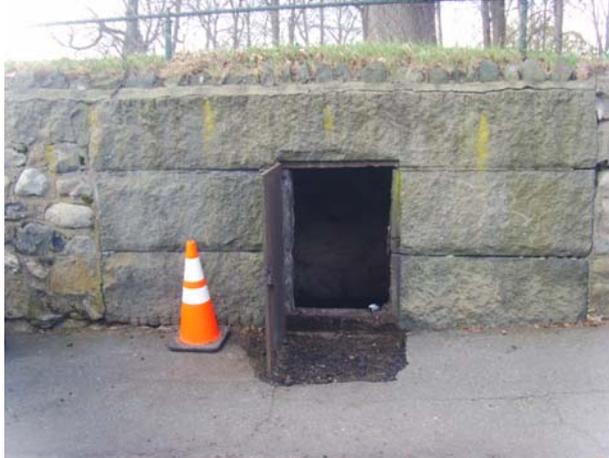
Town Receiving Tomb
Dated ca. 1845

The doors of the Town Tomb and Green Tomb can be removed and restored. Period locksets can be installed and the damaged areas repaired. The door can then be painted. It is possible to determine the original color of the doors as long as the original paint was not sand blasted off during a re-painting.

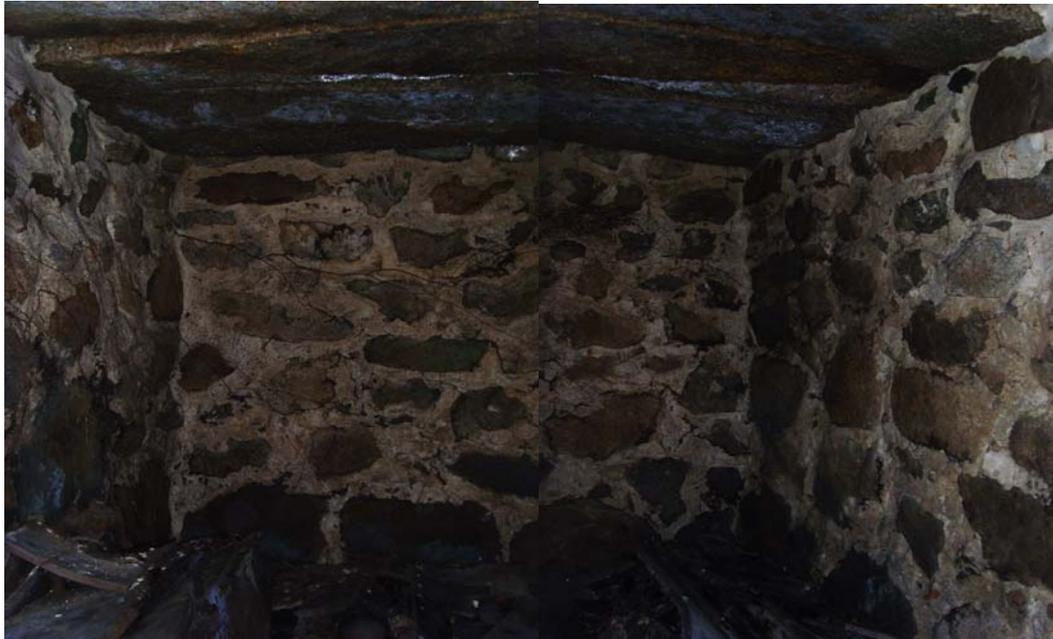
Composite Photo of the Interior of the Hill Tomb

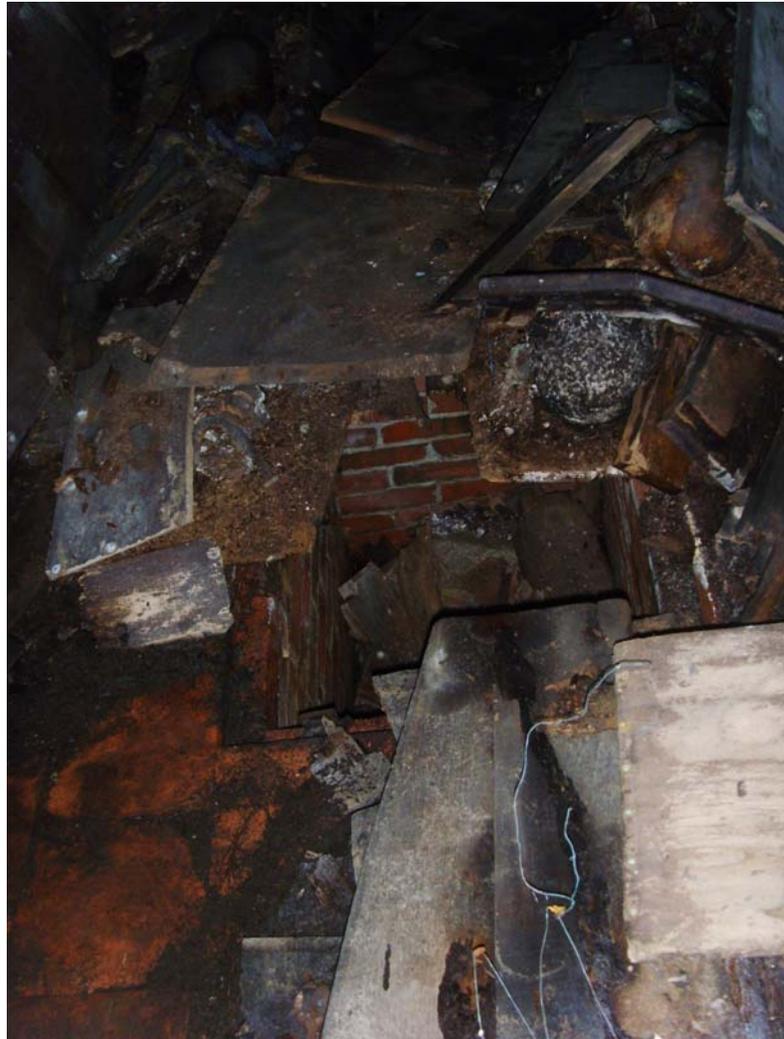
Floor of the Hill Tomb showing Clay Tile (to left) and Brick Well (center)

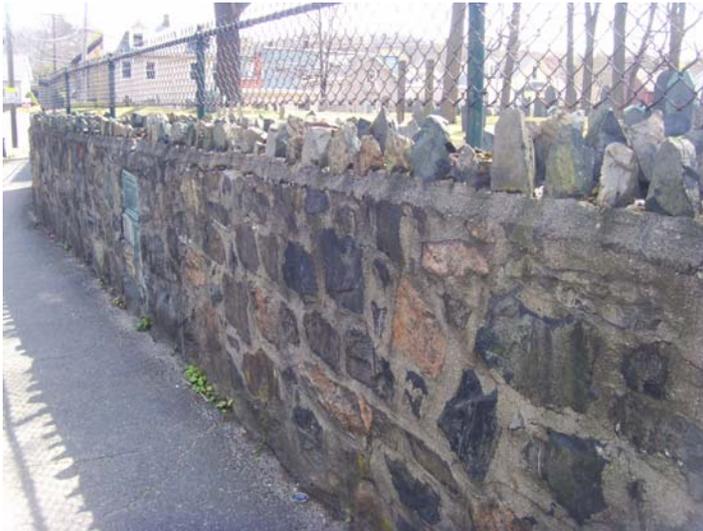
Pleasant Street Wall

The Pleasant Street wall has a jagged stone topping running from the tombs west to the end of the wall. It appears that this topping may also not be original to the walls based on the following observations. There is an obvious flat plane on the top course of stonework that separates the main wall from the jagged topping stones. Another clue is the fact that the mortar used to seat the jagged stones is cement based mortar. This type of mortar is not consistent with the age of the wall or the make-up of the interior wall joints. These stones may have been added when the fencing was installed in 1937.

The jagged stone topping on the Pleasant Street Walls does not appear to be original. This stone should be carefully removed and the top stones cleaned of any mortar.

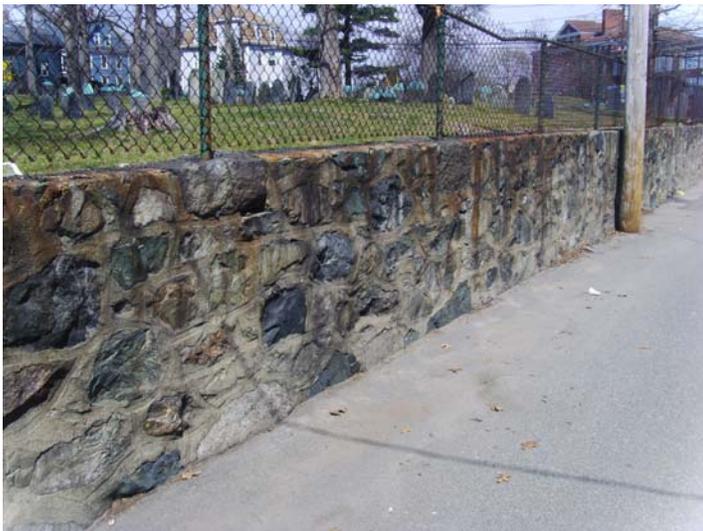
Oriental Court Wall

Concerns were raised about the condition of the return wall at the end of the Oriental Court Wall (adjacent to building). This portion of the wall has joints that are missing most of the mortar. The concerns were with regard to the structural integrity of this section of wall. There is crack in the adjacent wall section, which indicated some movement; however is it not severe and does not indicate a significant lack of structural integrity. This section of wall should be monitored over time for more pronounced movement. Based on past experience, this movement will most likely be very slow. It has taken almost 100 years for the crack to develop. It should take many more years for the movement to increase.

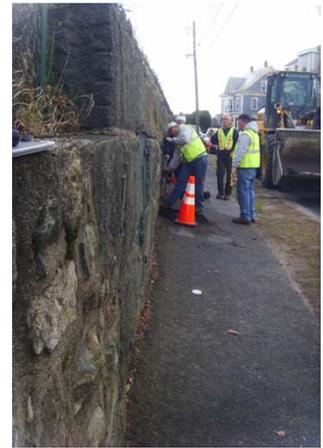
Photo 3

Inspection Items	Comments
Movement	The top stone is leaning slightly. The entire front facade has a very minor lean toward the street. See Photo 3.
Door	The hinges are rusted shut. One was broken while attempting to open the door. The door is in good condition. It has been repainted. The original rivets on the hinges are corroded and broken. There is impacted rust behind the hinges.
Joints	The bottom joint of the top course of stone is open. See Photo 1. The original joints were not mortared. The existing mortar is only partial depth. This was verified from the inside as well. See Photo 4.
Staining	Minor staining. Graffiti on door See Photo 2.
Plant Growth	Minor Lichen growth See Photo 1.
Overall Condition	Good
Short Term Repairs	Clean Front Exposed Surfaces
Long Term Repairs	Remove and reset front façade Install drainage behind façade stones Restore door and reset Remove jagged stoned on top of headstone

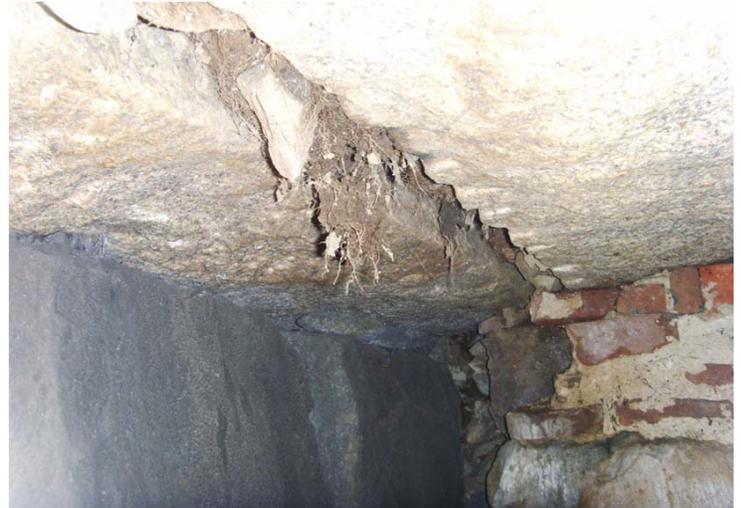
Photo 1

Inspection Items	Comments
Movement	Side and rear walls are stable Roof stones are stable Front façade has moved forward approximately 3", which has led to large opening in the corners and between the roof stones. Large amounts of soil have fallen into the front of the tomb. See Photo 1.
Dimensions	The interior dimensions of the tomb are as follows: Front to back: 13 feet Side to side: 8 feet Floor to ceiling: 6 feet Front wall thickness: 12" (granite)
Joints	The interior joints are all mortared. This may be an original condition. The front façade wall is not mortared.
Staining	Minor staining and moisture.
Floor	Unusual tile floor (8"x8" clay) Appears to be dry laid. There is an unusual sump pit in the middle of the tomb. It is 19"x32" and 24" deep. It is constructed with brick and may have been added as a dry well? See Photos 4 and 5.
Overall Condition	Fair
Short Term Repairs	None
Long Term Repairs	See exterior notes

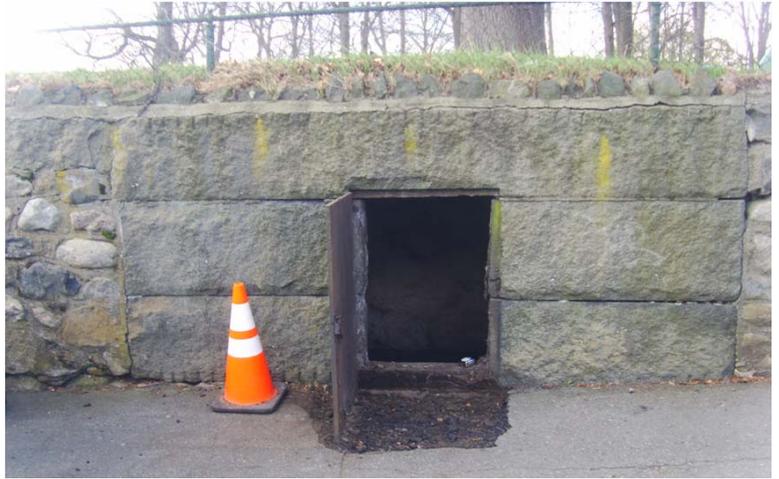
Photo 1

Inspection Items	Comments
Movement	The front façade is leaning slightly forward toward the street. See Photo 3.
Door	The hinges are heavily rusted. The door is in fair condition. It has been repainted. The lockset was corroded beyond repair.
Joints	Most of the joints are open to some degree. See Photo 1. The original joints were not mortared. The existing mortar is only partial depth. This was verified from the inside as well. See Photo 3.
Staining	Minor staining and graffiti. See Photo 1.
Plant Growth	Minor Lichen growth. See Photo 1.
Overall Condition	Good
Short Term Repairs	Clean Front Exposed Surfaces
Long Term Repairs	Remove and reset front façade Install drainage behind façade stones Restore door and reset Remove jagged stoned on top of headstone

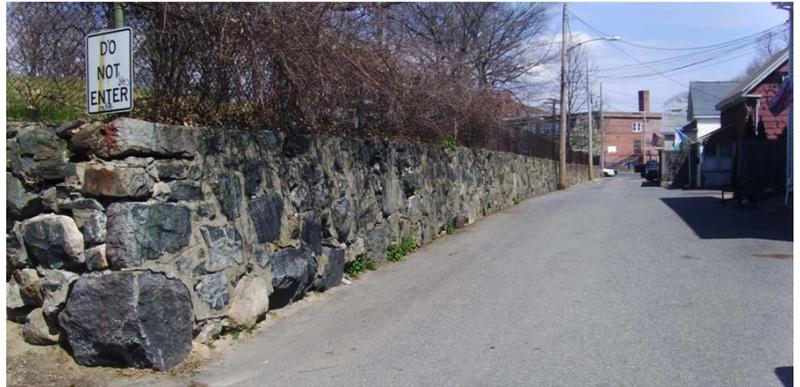
Photo 1

Inspection Items	Comments
Movement	Minor if any Most of the wall is very plumb and stable There is a crack near the corner caused by minor movement of the return wall. (just to the right of the "do not enter sign" in photo 1). Photo 3 also shows the crack.
Joints	The return wall near the adjacent building has rough joints with missing mortar. The joints in the main wall are smooth and made with cement based mortar. There is lime based mortar below the cement mortar, which most likely the original mortar. Photo 2 shows the two layers of mortar since the cement mortar has fallen away. Most of the joints are in fair to good condition. Many joints at the base of the wall are missing mortar. This is most likely due to snow plows or water.
Staining	There is staining from the corrosion of the chain link fencing. See Photo 4.
Plant Growth	There is significant plant growth on the fence near the far end. See Photo 1.

Fencing	The fencing is not original (added in 1937). The stones at the base of the posts do not the other stones in size and shape. They are larger and squared off. They were part of the original wall; however they supported an older fence (Town records).
Drainage	There are no signs of weep holes of foundation drains. There are areas behind the wall that can collect water; however there are no signs that this has caused distress to the wall.
Overall Condition	The wall is in very good condition considering the age. The wall is true and plumb with little sign of movement or settlement. The fencing is corroded and damaged.
Short Term Repairs	Repair and paint fence posts and rails. Replace chain link fabric. Repair damaged and missing pointing. Remove rust staining.
Long Term Repairs	Repoint entire wall with historic mortar Clean all surfaces Remove fence and install a new historically accurate fence.
