Map Number B8.14

Marker ID: 249

Marker Type Headstone

Gravemarker Name Last, First, Middle Sarah Hay

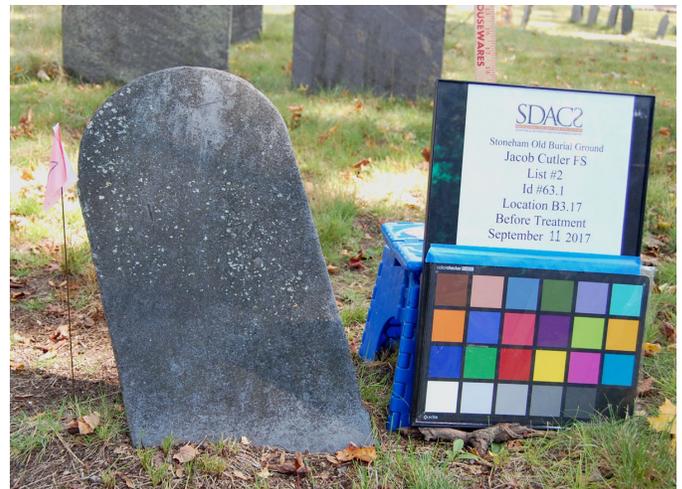
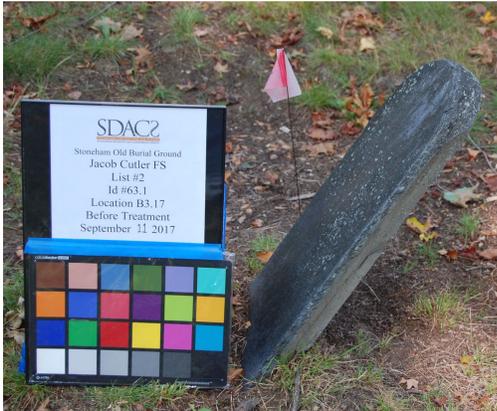
The object was leaning at a precarious angle.

The piece was reset and levelled into a mixture of 1:2 peastone and stone dust, with soil placed on top. It was also reset so that the footstone faced the east rather than the west. This is the orientation for the footstones in this area.

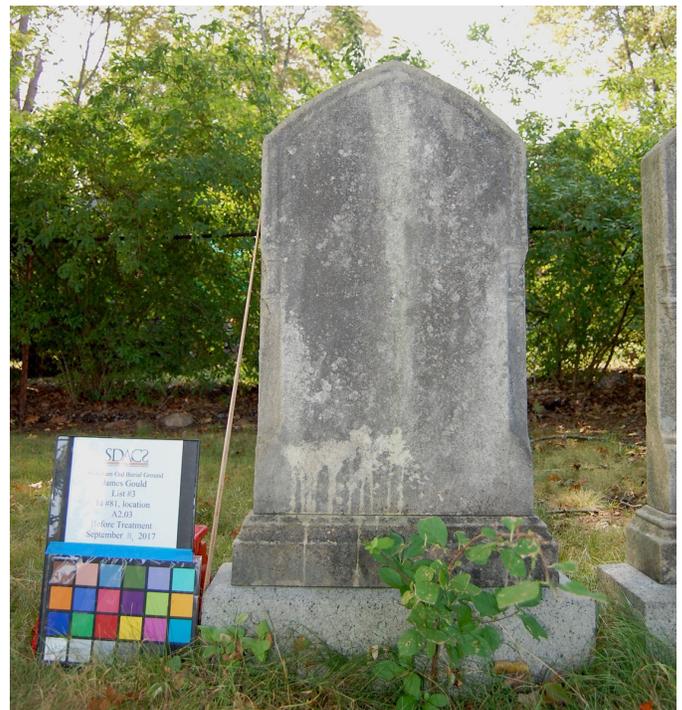
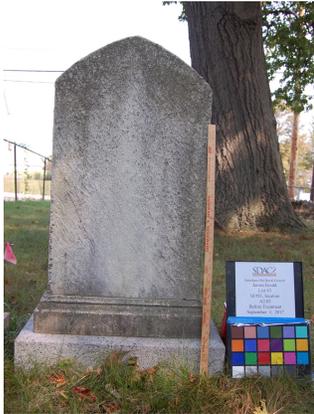
The mortar of the piece has failed and the piece can move and is hazardous.

The surface of the stone is stained and discolored by lichens and algae.

Two ferrous pins had been inserted into a hole that went from the upper marble through the marble pedestal into the granite base. These pins were cored out and the hole was cleaned. Two new notched stainless steel pins were inserted into the hole and set with Wood and Stone KG 321 epoxy. The marble to marble joint was additionally set with Jahn M70 Limestone Standard S1-LS mortar and the marble to granite joint was set with 1-1-6\* mortar. The piece was leveled and made plumb.

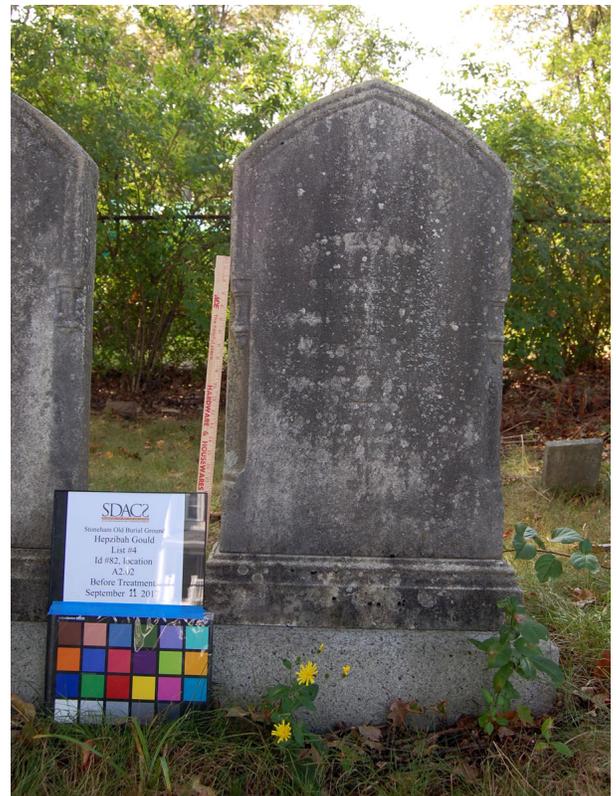
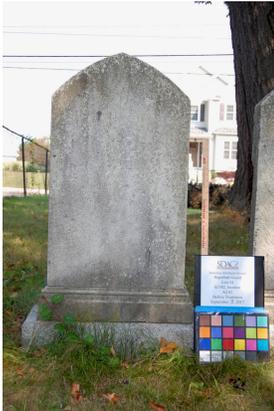
The mortar of the piece has failed and the piece can move and is hazardous.

The surface of the stone is stained and discolored by lichens and algae.

Two ferrous pins had been inserted into a hole that went from the upper marble through the pedestal into the granite base. These pins were cored out and the hole was cleaned. Two new notched stainless steel pins were inserted into the hole and set with Wood and Stone KG 321 epoxy. The marble to marble joint was additionally set with Jahn M70 Limestone Standard S1-LS mortar and the marble to granite joint was set with 1-1-6\* mortar. The piece was leveled and made plumb.

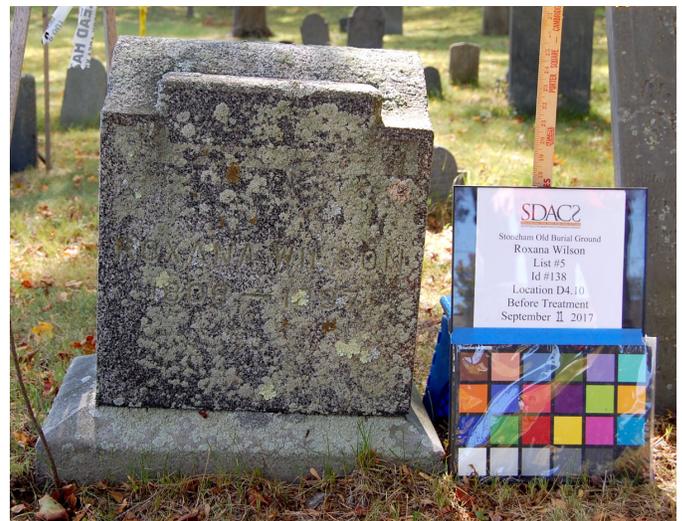
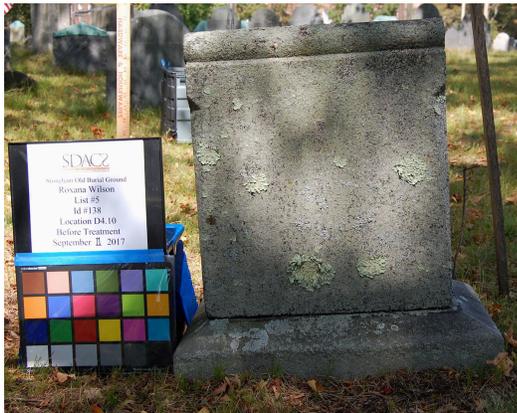
The mortar of the piece has failed and the piece can move and is hazardous. The marker is sitting at an angle.

The surface of the stone is stained and discolored by lichens and algae.

The base was reset plumb and level in a bed of 1:2 peastone: stone dust. Soil was replaced on top.

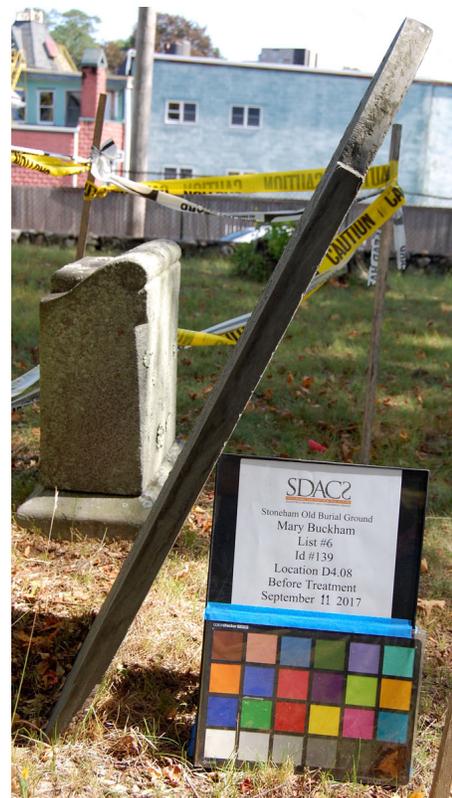
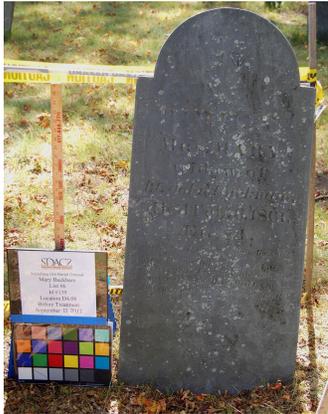
The condition of the piece is generally good, with the exception of its position, which is precarious. The piece is leaning at an angle of about 35-40 degrees.

The piece was excavated and reset plumb and level in a bed of 1:2 peastone: stone dust. Soil was replaced on top.

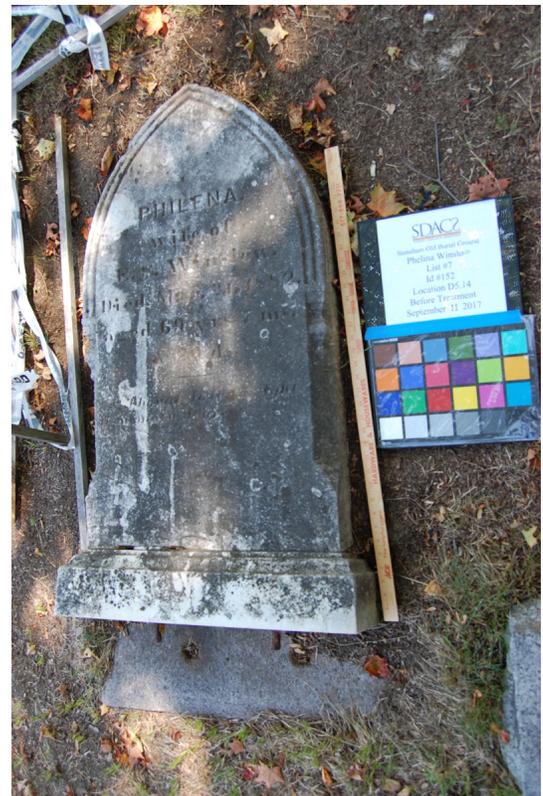
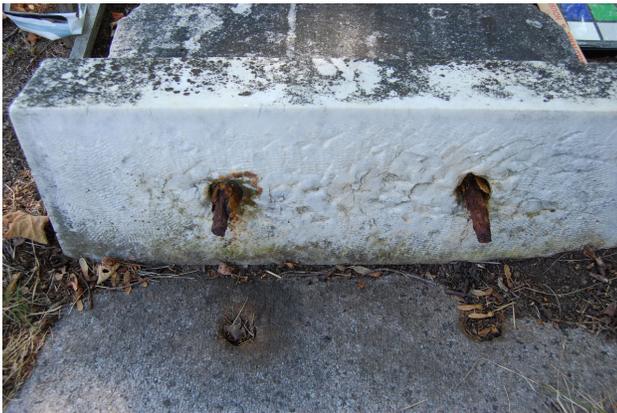
The marker is held to the base with two iron pins , which have rusted. These need to be replaced or removed. The upper section of the marble shows some loss at the bottom where it contacts the

The surface of the stone is also stained and discolored by lichens and algae.

Two ferrous pins had been inserted into a hole that went from the upper marble through the pedestal into the granite base. These pins were cored out and the hole was cleaned. Two new notched stainless steel pins were inserted into the hole and set with Wood and Stone KG 321 epoxy. The marble to marble joint was additionally set with Jahn M70 Limestone Standard S1-LS mortar and the marble to granite joint was set with 1-1-6\* mortar. The piece was leveled and made plumb.

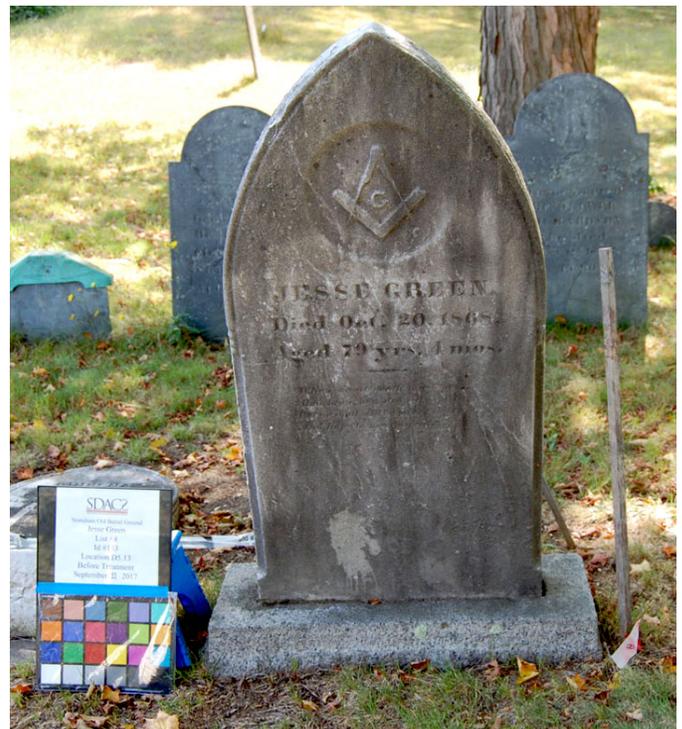
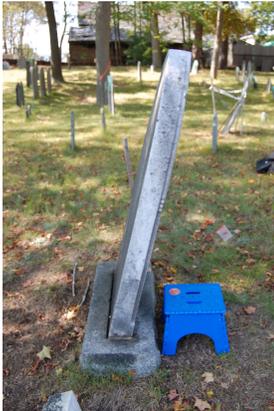
The grave marker is tilted and precarious. The mortar has failed and the piece needs to be reset.

The surface of the stone is also stained and discolored by lichens and algae.

Two ferrous pins had been inserted into a hole that went from the upper marble through the pedestal into the granite base. These pins were cored out and the hole was cleaned. Two new notched stainless steel pins were inserted into the hole and set with Wood and Stone KG 321 epoxy. The marble to marble joint was additionally set with Jahn M70 Limestone Standard S1-LS mortar and the marble to granite joint was set with 1-1-6\* mortar. The piece was leveled and made plumb.

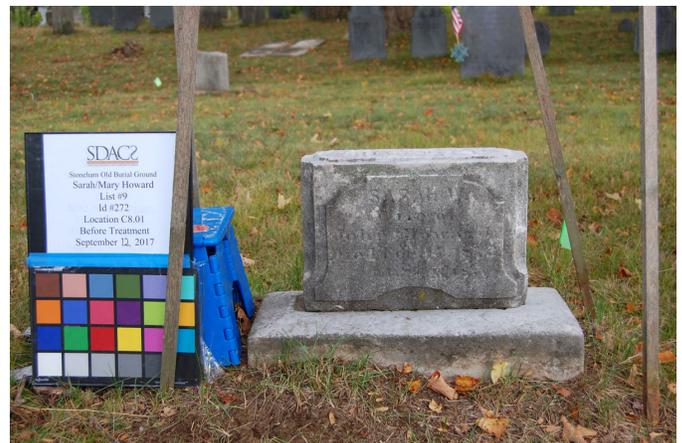
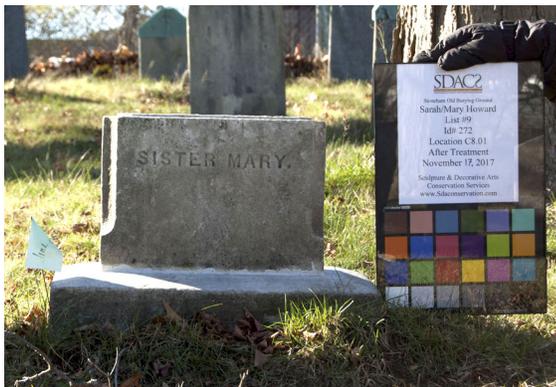
The marker is loose on its base and needs to be reset.

The surface of the stone is also stained and discolored by lichens and algae.

On separating the top and bottom sections of the markers, two empty holes were revealed. These appear to have previously held iron dowels, now missing. This would substantiate the notion that the piece is a reduced version of the original - cut and reshaped from the original, taller marble gravemarker.

The piece was cleaned with water. A new notched stainless steel pin was inserted into the hole and set with Wood and Stone KG 321 epoxy. The marble to marble join was additionally set with Jahn M70 Limestone Standard S1-LS mortar. The piece was leveled and made plumb.

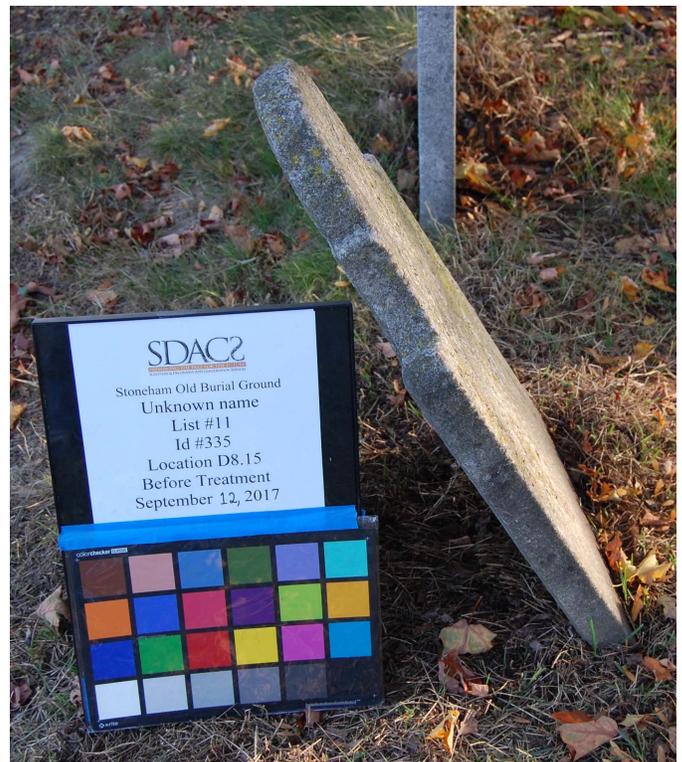
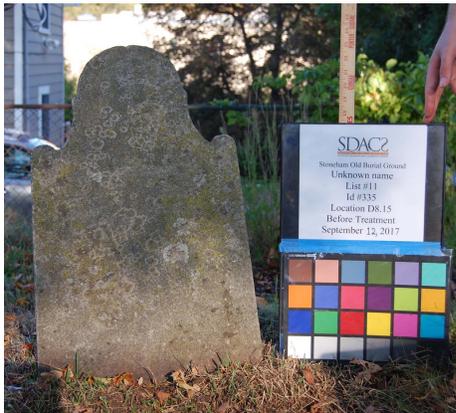
The object is in very poor condition. The top is riddled with deep cracks. When the object was excavated, the bottom third was found to have broken off. The surface is very sugary, showing extensive decay and is heavily stained.

The piece was cleaned using a fungicide, D2 Biological Solution. This improved the readability of the surface and showed deep cracks in the top of the piece. The cracks were filled with Jahn M70 Limestone Standard LS-1 restoration mortar. The piece was covered with damp canvas and polyethylene and left to cure for several days prior to exposure to the weather. The weather was in the 40s with no rain for three days following the repointing.

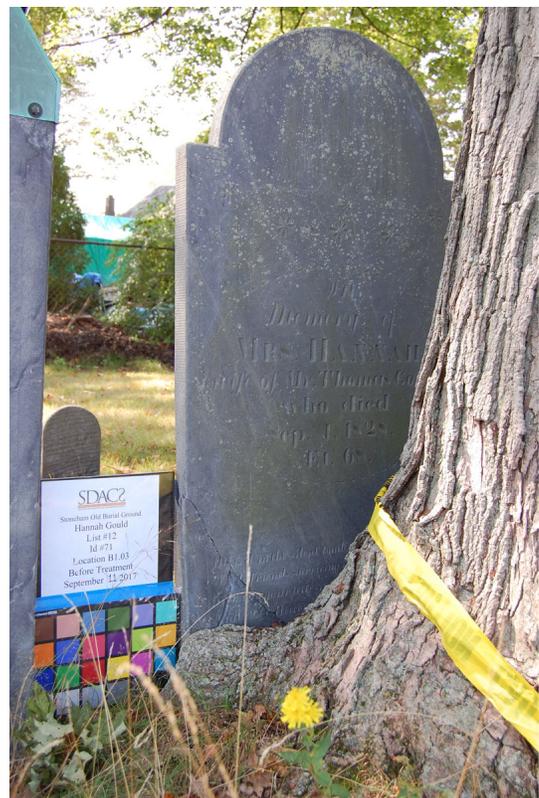
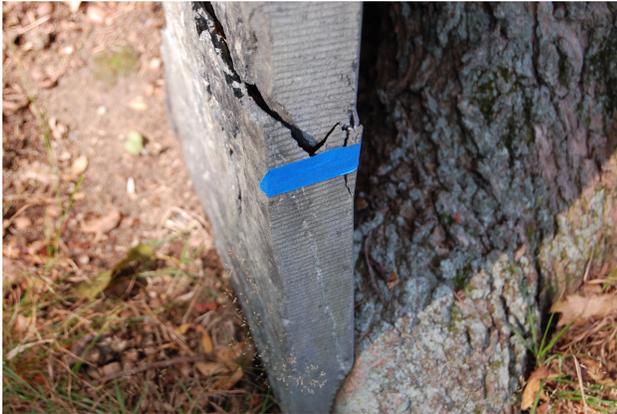
According to the Stoneham Historical Society notes, "Since the 2012 assessment, this tree has grown and cracked the stone". The piece is in extremely fragile condition, with several large breaks on the proper right rear bottom side that are held in place by the tree root. Two small fragments from the front were discovered during the initial examination. Much debris had fallen into the gaps between the fragments of the stone.

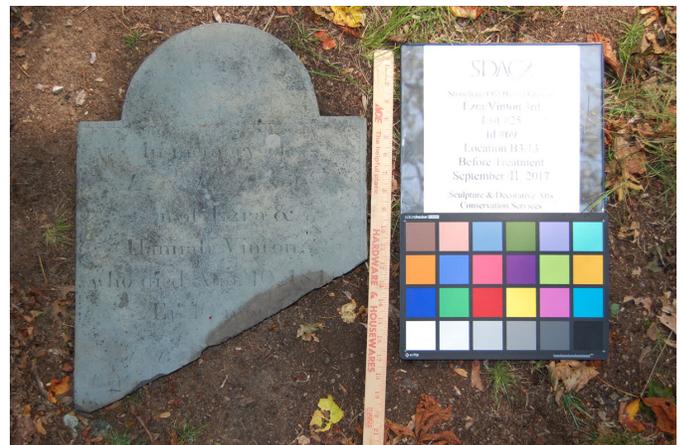
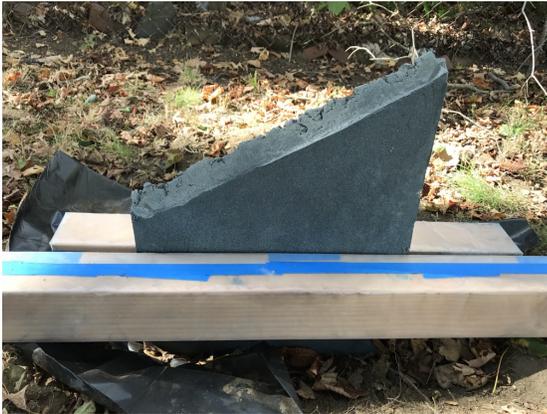
The marker broke along a diagonal and is missing its lower half.  
The piece is also stained with bioflora and is weathered.

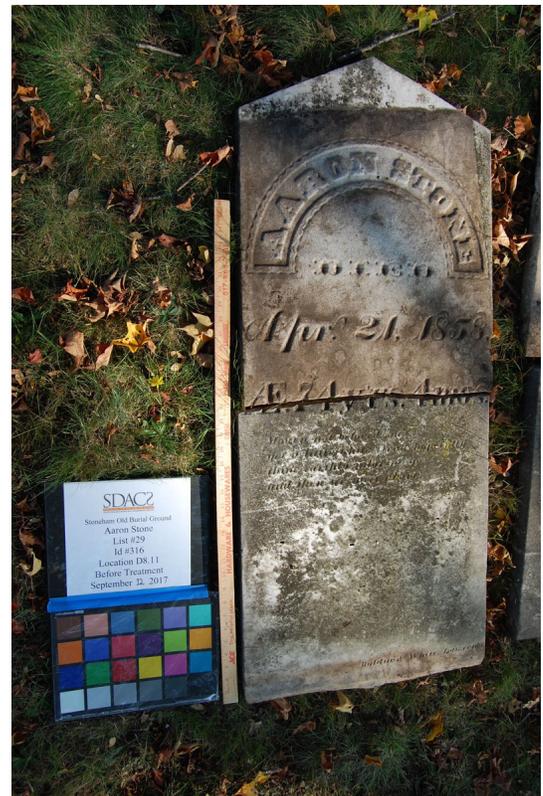
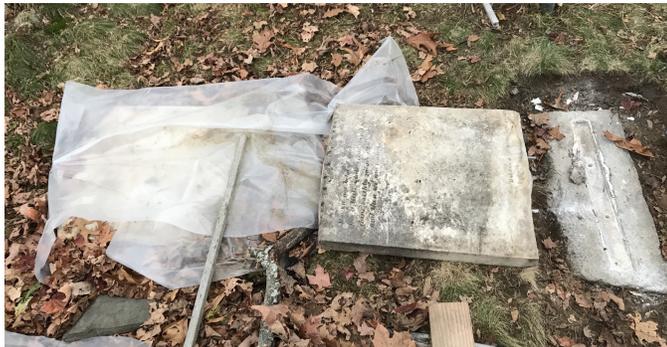
The lower fragment of the piece was held in the granite base intact, however the other 2 fragments clearly belonged much higher up on the piece. There was a large section of loss in the middle.

The piece was cleaned using D2 Biological Solution.

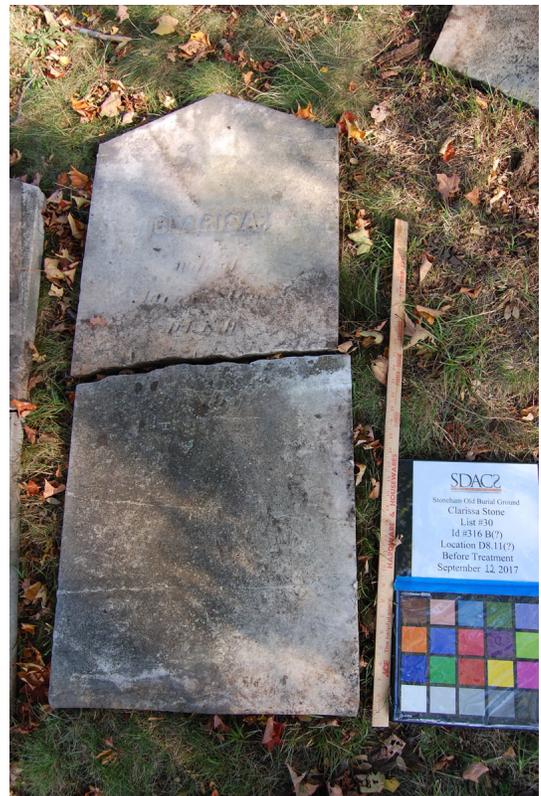
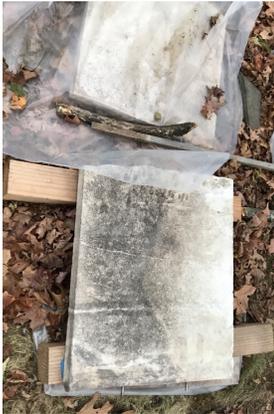
The marker is broken into two fragments. The piece is stained from the soil and microflora.

The central join was adhered together with the same epoxy and filled with the Jahn restoration mortar as well.

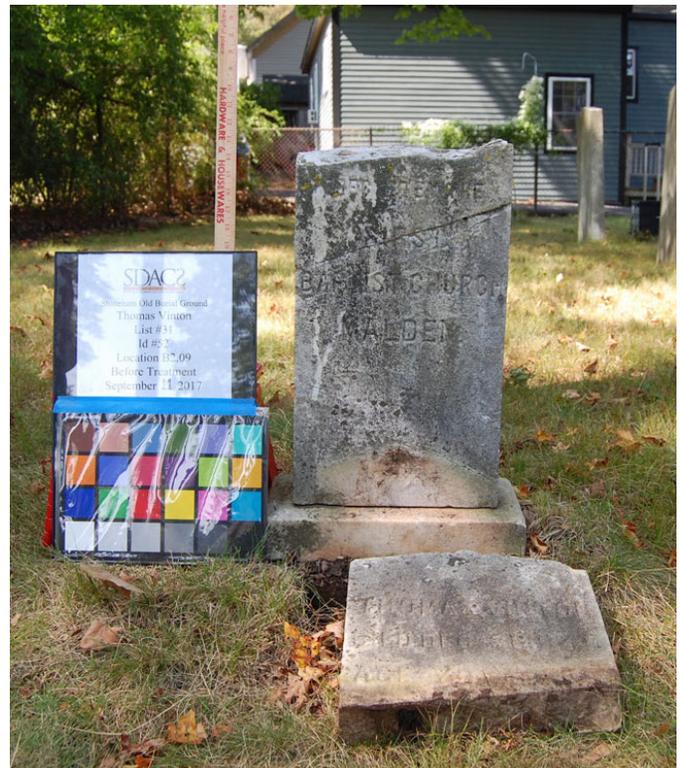
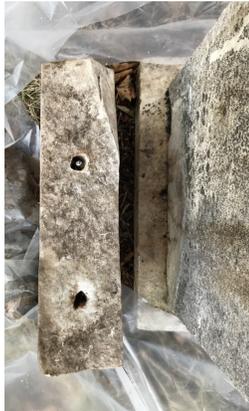
The piece is covered with dirt and black algae.  
The earlier repair has failed due to rusting iron pins and the top fragment is now on the ground.

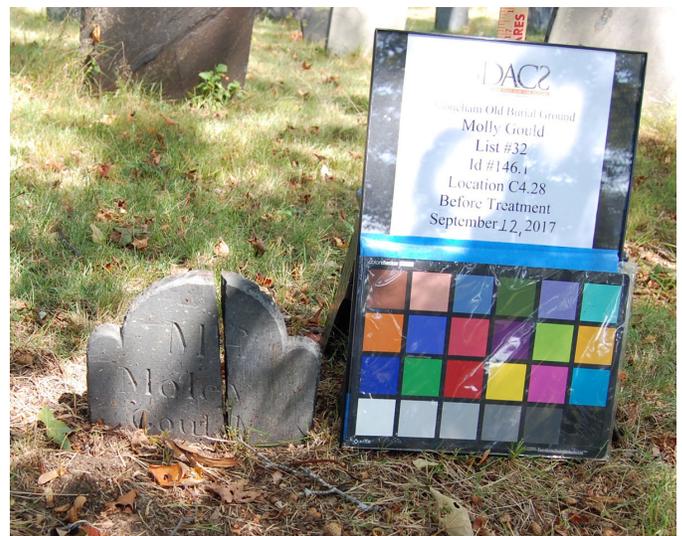
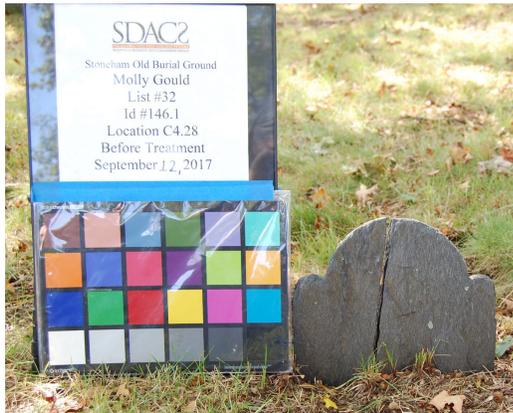
The marker is broken vertically in half.

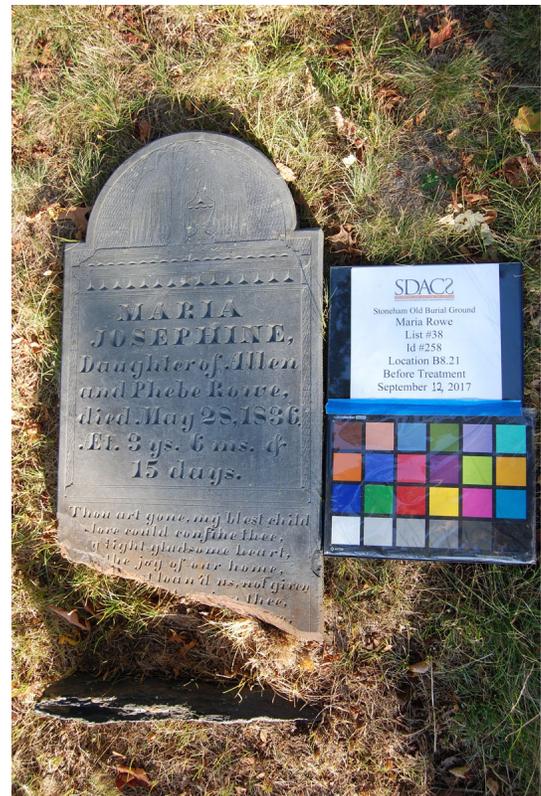
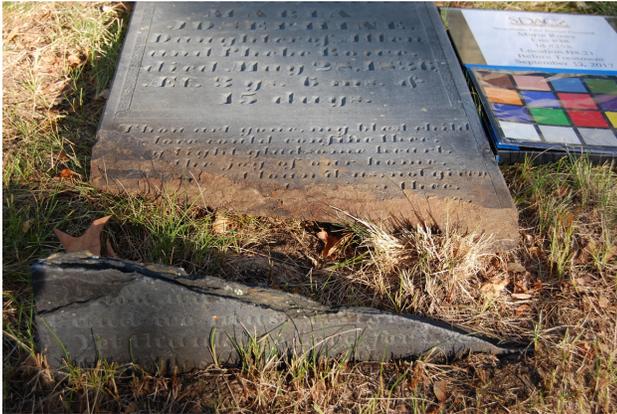
The piece is dirty and stained near the ground.

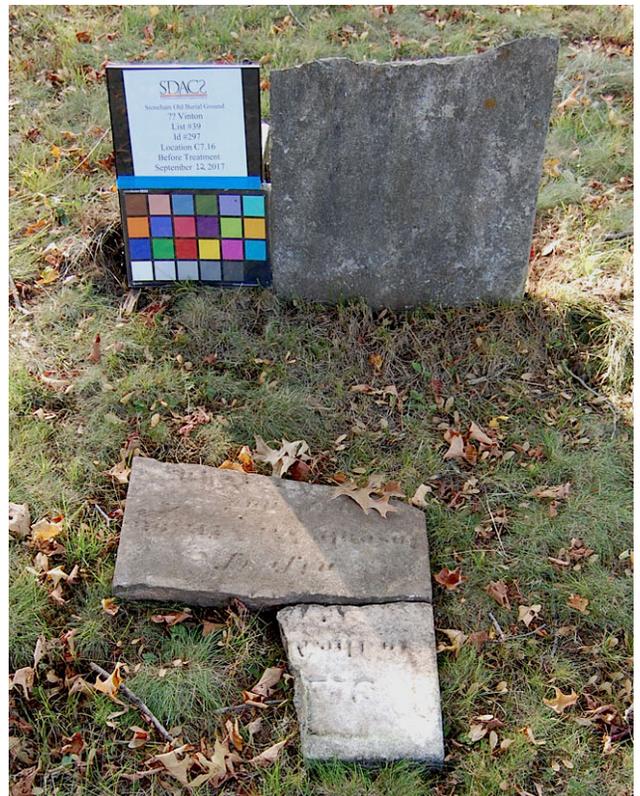
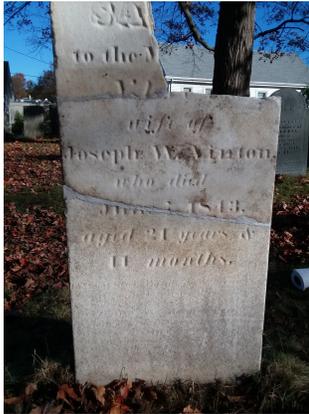
The piece was broken into three sections. A large section in the upper proper left was missing. Overall the pieces were stained brown and covered with the remnants of algae and lichens that have turned black.

The upper right large loss was filled over a period of several days using Limeworks Lithomix. Initially, two stainless steel dowels were embedded vertically in the stone using Akemi 5010 epoxy to support the fill. Another stainless steel dowel was embedded between the first and second days' application of Lithomix. After filling was complete and the Lithomix was cured, the fill was filed down and shaped.

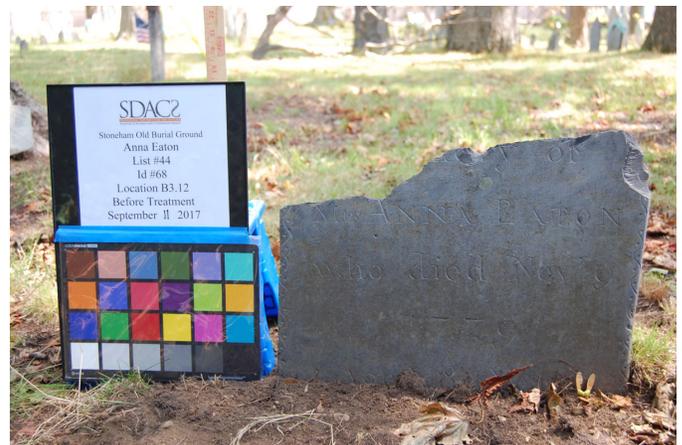
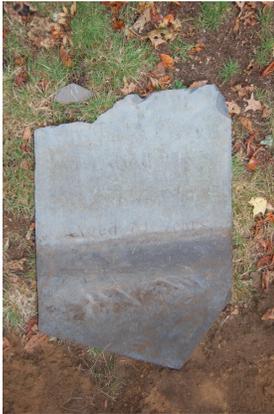
The marker was sunken into the earth by about 4 inches. It was dirty and covered with a moderate amount of lichens and bioflora.

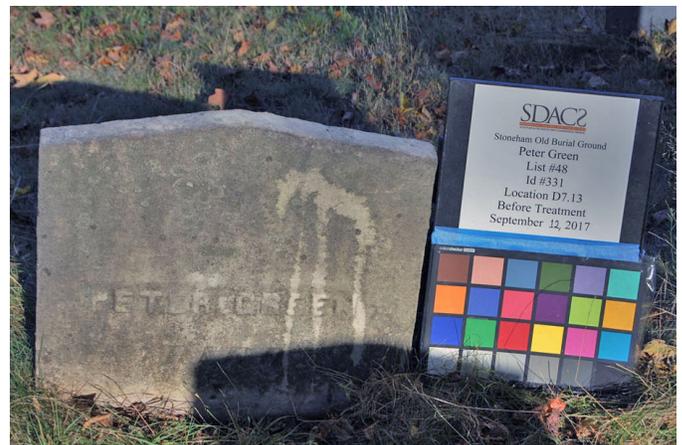
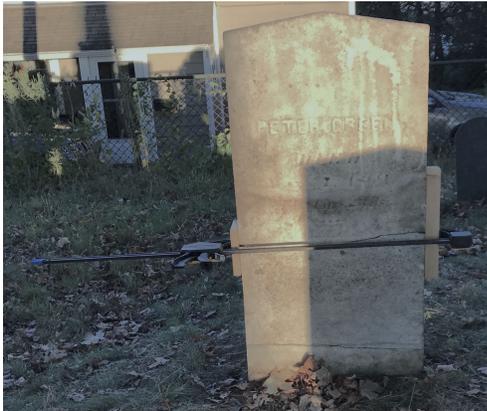
The piece is soiled and stained as well. It is set into a slotted base, but this was not excavated as it was level.
