## CODE COMPLIANCE:

### 521 CMR Mass. Architectural Access Board Regulations:

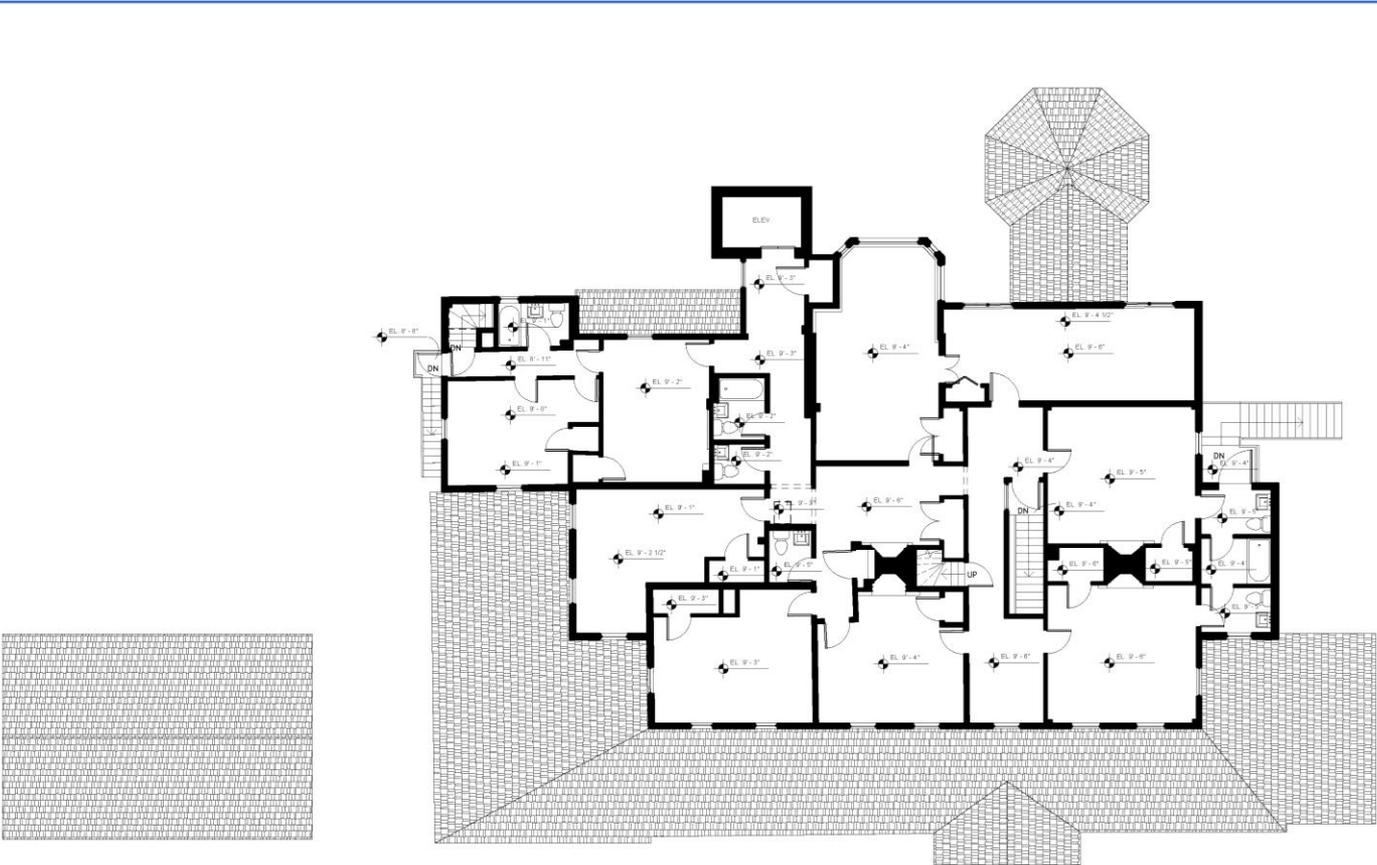
Second Floor Plan

- Observed deficiencies include:
  - On the second floor, near the east side of the building, there is a badly sagging floor. ***We strongly recommend that the Town restrict access to the use of this space until further investigation of this potentially unsafe condition is completed.***

- Recommend engaging a structural engineer to perform a floor loading analysis to confirm the existing floor framing has adequate capacity to support the increased floor loads. The floor loading analysis may require invasive exploration and removal of ceiling finishes as well as some wall finishes. ***Floor reinforcing will likely be required.***

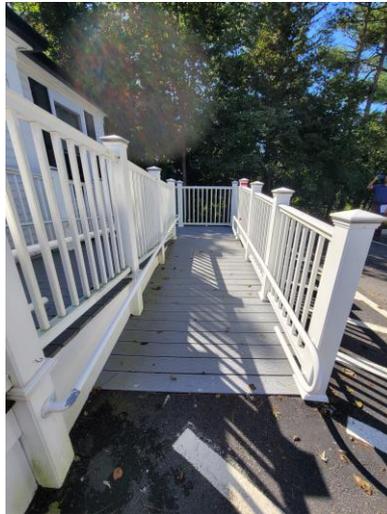
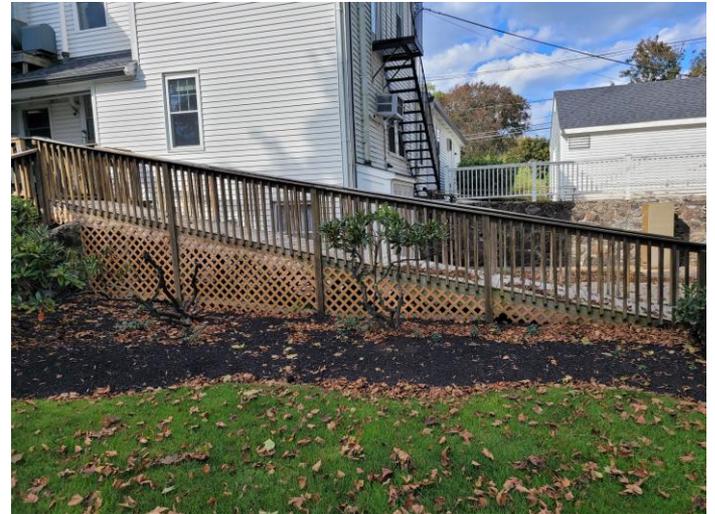
- If the work performed, including the exempted work, amounts to 30% or more of the full and fair cash value of the building the entire building is required to comply with 521 CMR.
- Current assessed building value (per Town Assessment Office):  $\$408,500 \times 30\% = \$122,550$
- Observed deficiencies include:
  - All public entrances
  - Ramps and walkways
  - Parking spaces
  - Stairs:
    - Handrails
    - Nosings
  - Public Toilet Rooms
  - Doors and hardware
  - Signage

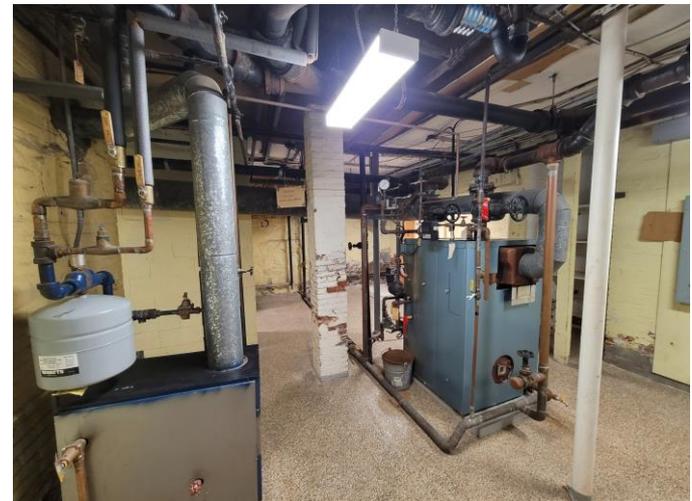
- The fan coil unit serving the sunroom must be shut down to prevent moldy air from the basement to be introduced into the sunroom.
- Kitchen exhaust hood should not be operated until a make-up air unit has been installed, if the new Owners decide to keep the commercial kitchen hood.
- Provide a fresh air system to all interior areas.
- Provide combustion air to rooms where boilers are located in accordance with code
- The gas-fired boilers appear to be in fair to good condition. All three boilers are out of production. Spare parts might be difficult to procure.
  - Replace boilers on an as-needed basis ?
  - Provide all new high efficiency direct-vent boilers?

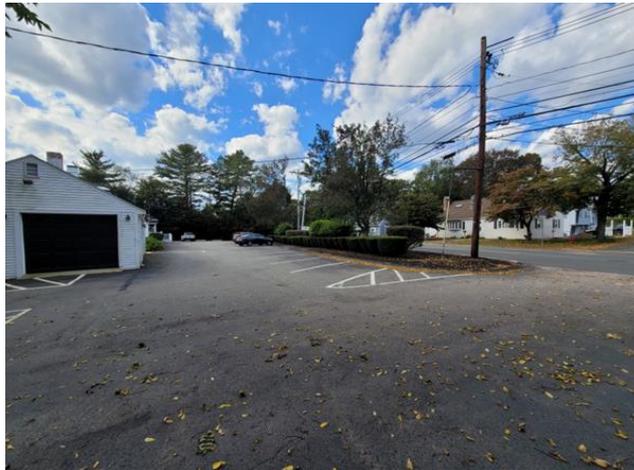
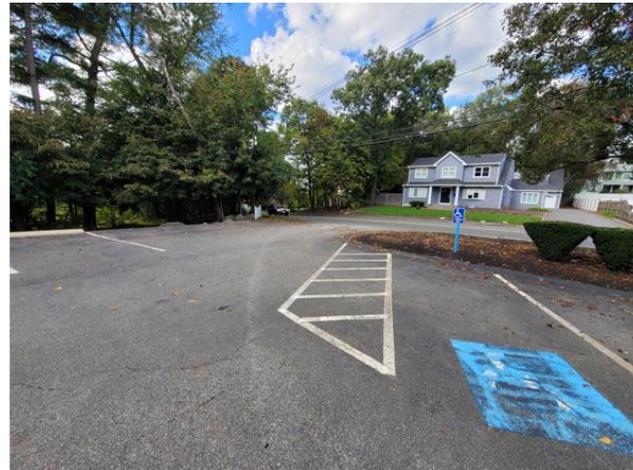
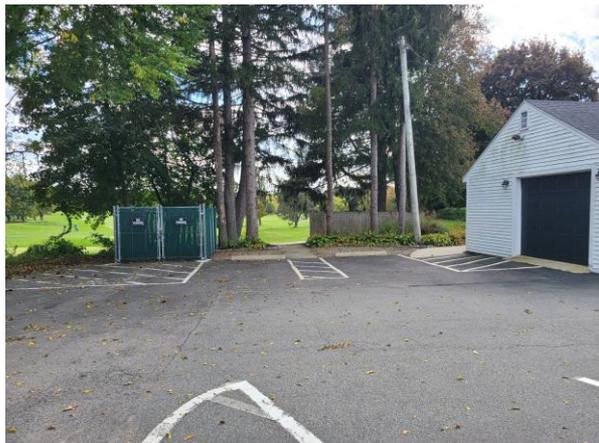
- 18 existing parking spaces (1 designated ADA space at end of angled parking)
- Existing garage with space for 2 cars
