Preserving the substance and significance of gravestones

CONDITIONS SUMMARY,
CONSERVATION RECOMMENDATIONS
AND
CONDITION ASSESSMENTS

OLD BURYING GROUND
STONEHAM, MA

April 2012

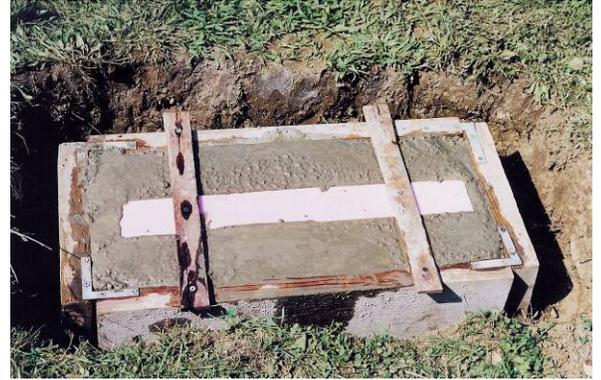
Above, the poured base with setting form in place

The bases are minimally 12 inches deep, 12 inches greater in thickness and 6 inches wider than the stone itself. Once the concrete has cured, forms are removed and the stones are reset into the slot as above.

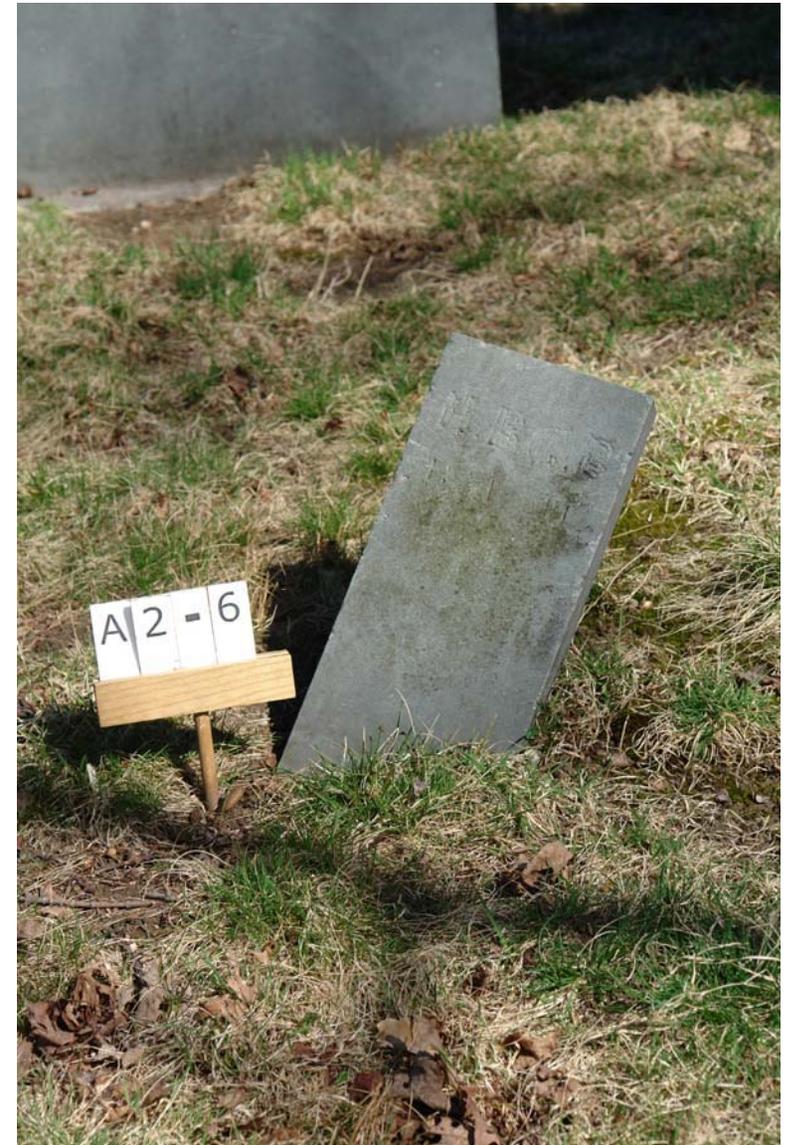
Exist # **77.1**

NAME ON MARKER **H.B. G. B. (George and Hannah Buckman)**

Death Date: Material: **slate** Marker Type: **Footstone**

EXISTING CONDITIONS	CONSERVATION STRATEGY
Tilted	Reset

3

1. Excavate footstone; remove soil from setting area to appropriate depth.
2. Remove soiling by light brushing with nylon brushes and water
3. Re-set footstone plumb at appropriate height and level onto gravel bed, aligned with adjacent markers
4. Backfill area around footstone with tamped sand and gravel
5. Re-grade disturbed areas with existing topsoil.
