ENGINEERING ASSESSMENT OF STRUCTURES AT THE OLD BURYING GROUND STONEHAM, MASSACHUSETTS

Cemetery	Stoneham Old Burying Ground		
Inspection Date	April 11, 2012	Inspector	Pete Culmo

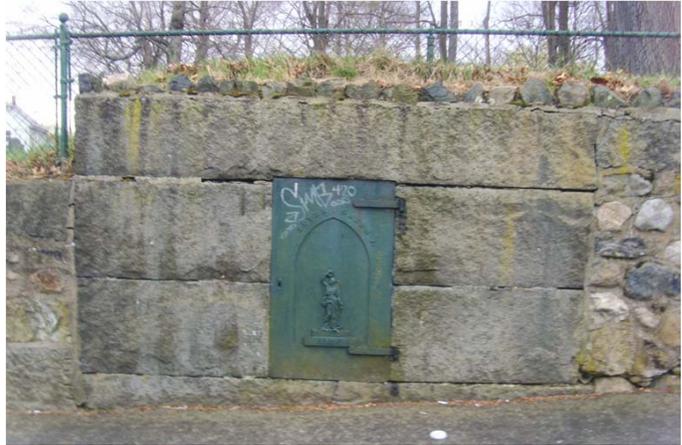
Photo 1

Inspection Items	Comments
Movement	The top stone is leaning slightly. The entire front facade has a very minor lean toward the street. See Photo 3.
Door	The hinges are rusted shut. One was broken while attempting to open the door. The door is in good condition. It has been repainted. The original rivets on the hinges are corroded and broken. There is impacted rust behind the hinges.
Joints	The bottom joint of the top course of stone is open. See Photo 1. The original joints were not mortared. The existing mortar is only partial depth. This was verified from the inside as well. See Photo 4.
Staining	Minor staining. Graffiti on door See Photo 2.
Plant Growth	Minor Lichen growth See Photo 1.
Overall Condition	Good
Short Term Repairs	Clean Front Exposed Surfaces
Long Term Repairs	Remove and reset front façade Install drainage behind façade stones Restore door and reset Remove jagged stoned on top of headstone

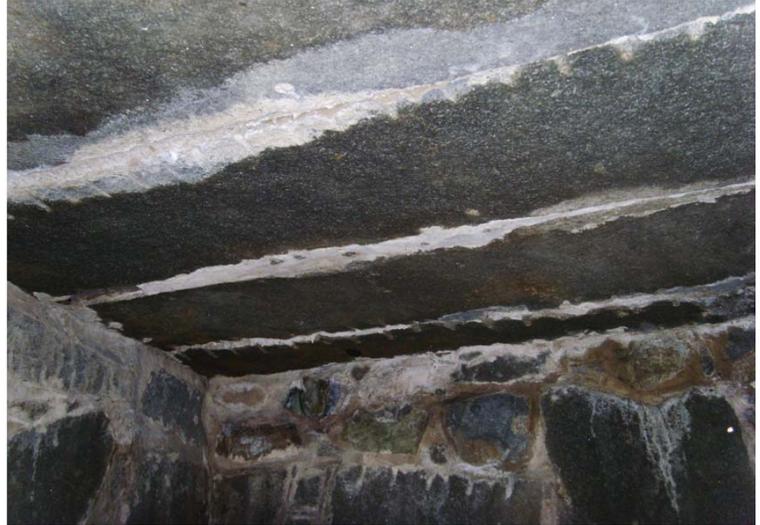
Photo 1

Inspection Items	Comments
Movement	Side and rear walls are stable Roof stones are stable Front façade has moved forward approximately 1", which has led to minor cracks in the side walls near the front
Dimensions	The interior dimensions of the tomb are as follows: Front to back: 10 feet Side to side: 8 feet Floor to ceiling: 6 feet Front wall thickness: 12" (granite)
Joints	The interior joints are all mortared. This may be an original condition. The front façade wall is not mortared.
Staining	Most of the joints have efflorescence staining (white stains) caused by water infiltration.
Floor	Cementitious mortar floor
Overall Condition	Good
Short Term Repairs	None
Long Term Repairs	See exterior notes

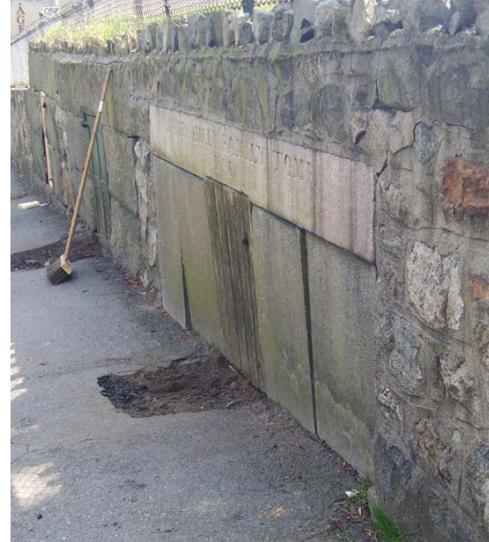
Photo 1

Inspection Items	Comments
Movement	All façade stones are leaning and shifting. There is a significant lean of 3" toward the street.
Door	The original door has been replaced. A wood door was found inside the tomb. It may not be the original door, but it could be a replica of the original door. It is a flat wood door with no significant ornamentation or detail. The original hinges and lockset bolt recess can be seen. See Photo 4.
Joints	Many of the joints are open. See Photo 1. The original joints were not mortared. This was verified from the inside as well.
Staining	Minor staining. See Photo 1.
Plant Growth	Minor Lichen growth. See Photo 1.
Overall Condition	Fair to Poor
Short Term Repairs	Clean Front Exposed Surfaces
Long Term Repairs	Remove and reset front façade. Install drainage behind façade stones. Replicate and install new door. Remove jagged stoned on top of headstone.

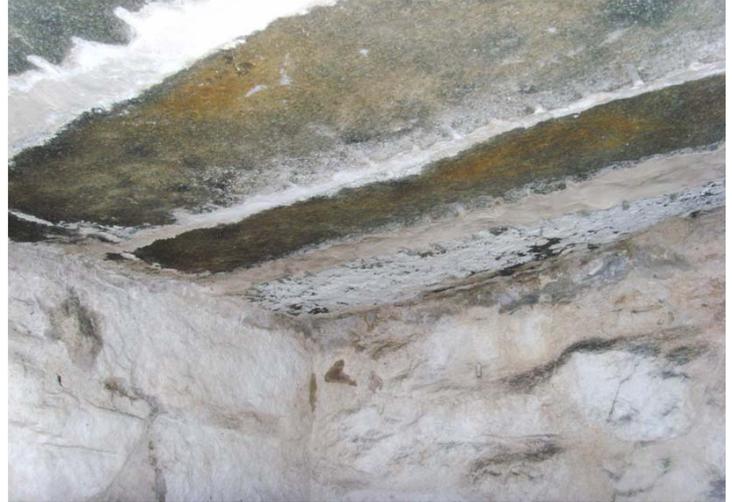
Photo 1

Inspection Items	Comments
Movement	Side and rear walls are stable Roof stones are stable Front façade has moved forward approximately 1", which has led to minor cracks in the side walls near the front There is minor amounts of soil that has fallen through the open roof joint.
Dimensions	The interior dimensions of the tomb are as follows: Front to back: 10 feet Side to side: 8 feet Floor to ceiling: 6 feet Front wall thickness: 8" (granite)
Joints	The interior joints are all mortared. This may be an original condition. The front façade wall is not mortared.
Staining	Most of the joints have efflorescence staining (white stains) caused by water infiltration. The walls are white washed.
Floor	Cementitious mortar floor
Overall Condition	Good
Short Term Repairs	None
Long Term Repairs	See exterior notes

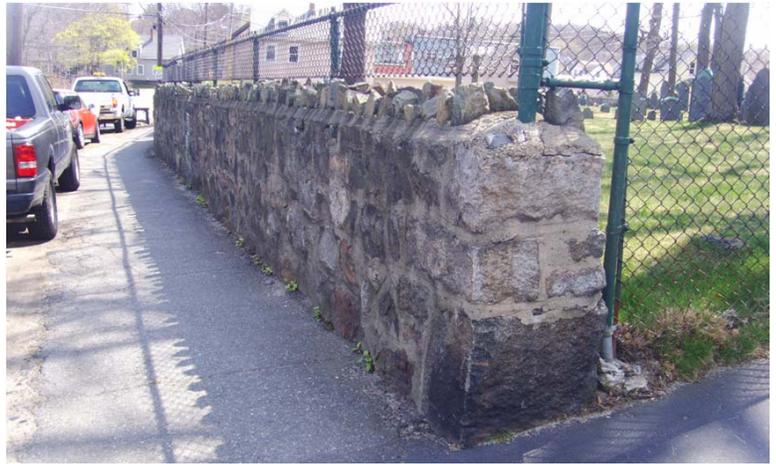
Photo 1

Inspection Items	Comments
Movement	None Most of the wall is very plumb and stable There is a crack near the Oriental Court corner caused by minor movement of the wall.
Joints	The joints are smooth and made with cement based mortar. There is lime based mortar below the cement mortar, which is most likely the original mortar. See Photo 2 shows the two layers of mortar since the cement mortar has fallen away. Most of the joints are in fair to good condition.
Staining	There is staining from the corrosion of the chain link fencing.
Plant Growth	There is significant plant growth on the fence near the far end. See Photo 1. There is minor lichen and moss growth.
Fencing	The jagged stones on top of the wall do not appear to be original. They do not match the details on the Oriental Court wall and the mortar used to adhere the stones is cement based. The fencing is not original (see notes on the Oriental Court Wall). The gate is corroded and damaged, but still functional.

Drainage	There are no signs of weep holes of foundation drains. There are areas behind the wall that can collect water; however there are no signs that this has caused distress to the wall.
Overall Condition	The wall is in very good condition considering the age. The wall is true and plumb with little sign of movement or settlement. The fencing and gate are corroded and damaged.
Short Term Repairs	Repair and paint fence posts, gate and rails. Replace chain link fabric. Repair damaged pointing. Remove rust staining.
Long Term Repairs	Repoint entire wall with historic mortar Clean all surfaces Remove fence and install a new historically accurate fence. Remove jagged stone.
