Map Number B8.14

Marker ID: 249

Marker Type Headstone

Gravemarker Name Last, First, Middle Sarah Hay

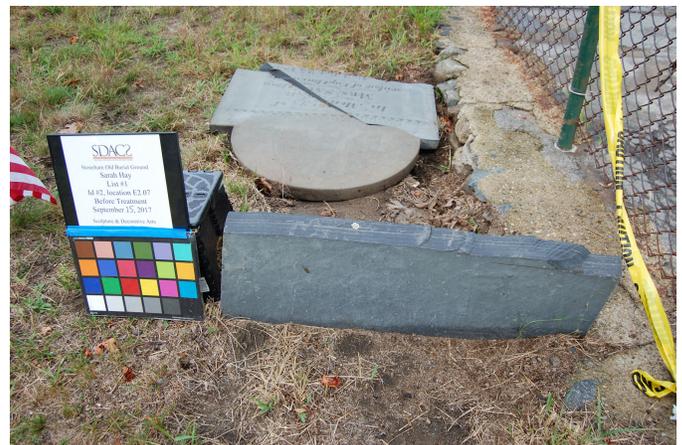
**Image Before Treatment**

See Monument Conservation Collaborative LIC notes from 2012.

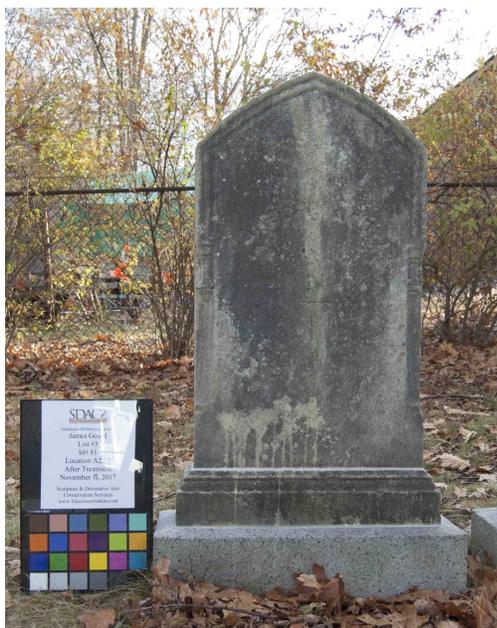
Image After Treatment

The mortar of the piece has failed and the piece can move and is hazardous.

The surface of the stone is stained and discolored by lichens and algae.

Two ferrous pins had been inserted into a hole that went from the upper marble through the marble pedestal into the granite base. These pins were cored out and the hole was cleaned. Two new notched stainless steel pins were inserted into the hole and set with Wood and Stone KG 321 epoxy. The marble to marble joint was additionally set with Jahn M70 Limestone Standard S1-LS mortar and the marble to granite joint was set with 1-1-6\* mortar. The piece was leveled and made plumb.

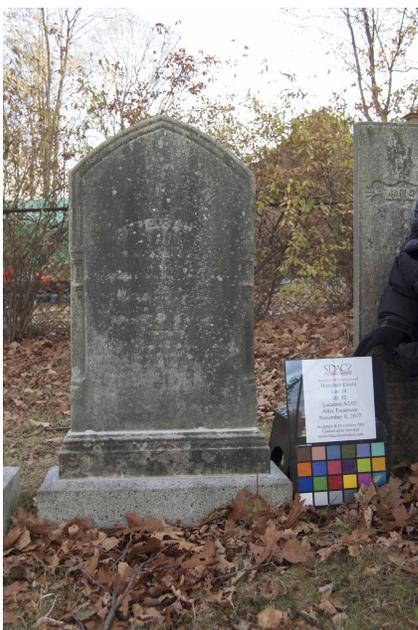
Image After Treatment

The mortar of the piece has failed and the piece can move and is hazardous.

The surface of the stone is stained and discolored by lichens and algae.

Two ferrous pins had been inserted into a hole that went from the upper marble through the pedestal into the granite base. These pins were cored out and the hole was cleaned. Two new notched stainless steel pins were inserted into the hole and set with Wood and Stone KG 321 epoxy. The marble to marble joint was additionally set with Jahn M70 Limestone Standard S1-LS mortar and the marble to granite joint was set with 1-1-6\* mortar. The piece was leveled and made plumb.

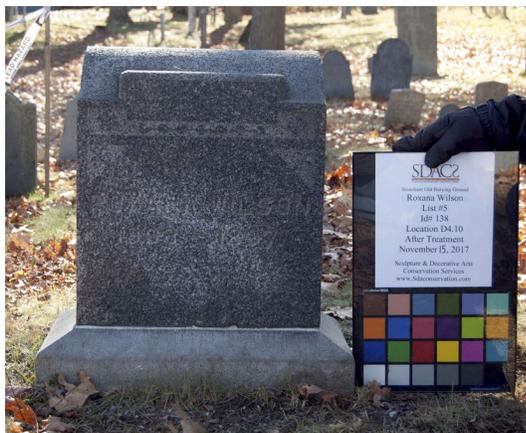
Image After Treatment

The mortar of the piece has failed and the piece can move and is hazardous. The marker is sitting at an angle.

The surface of the stone is stained and discolored by lichens and algae.

The base was reset plumb and level in a bed of 1:2 peastone: stone dust. Soil was replaced on top.

The upper section was mortared to the lower section using 1-1-6\* mortar.

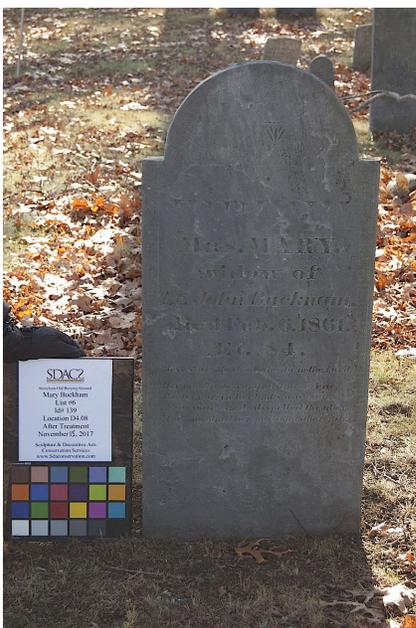
Image After Treatment

The condition of the piece is generally good, with the exception of its position, which is precarious. The piece is leaning at an angle of about 35-40 degrees.

The piece was excavated and reset plumb and level in a bed of 1:2 peastone: stone dust. Soil was replaced on top.

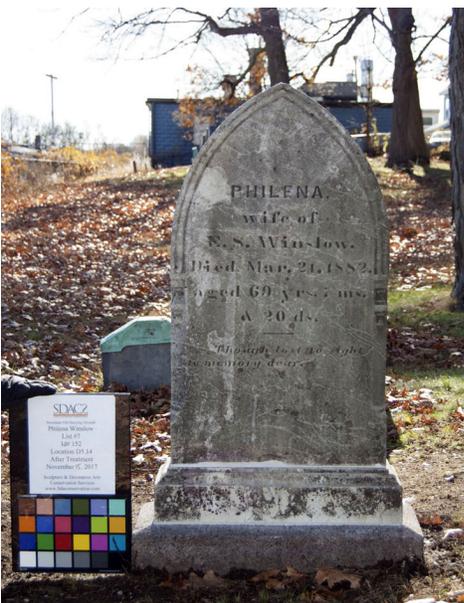
Image After Treatment

The marker is held to the base with two iron pins , which have rusted. These need to be replaced or removed. The upper section of the marble shows some loss at the bottom where it contacts the

The surface of the stone is also stained and discolored by lichens and algae.

Two ferrous pins had been inserted into a hole that went from the upper marble through the pedestal into the granite base. These pins were cored out and the hole was cleaned. Two new notched stainless steel pins were inserted into the hole and set with Wood and Stone KG 321 epoxy. The marble to marble joint was additionally set with Jahn M70 Limestone Standard S1-LS mortar and the marble to granite joint was set with 1-1-6\* mortar. The piece was leveled and made plumb.

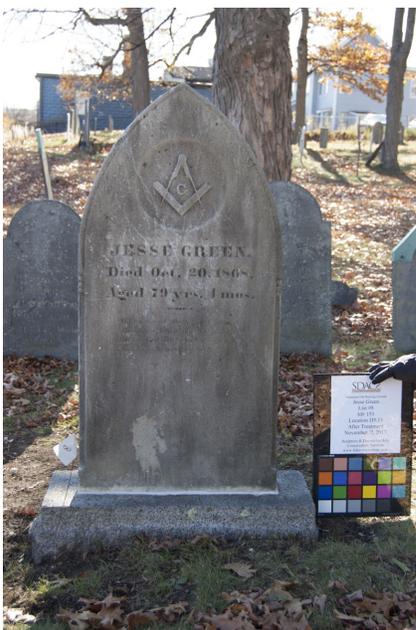
Image After Treatment

The grave marker is tilted and precarious. The mortar has failed and the piece needs to be reset.

The surface of the stone is also stained and discolored by lichens and algae.

Two ferrous pins had been inserted into a hole that went from the upper marble through the pedestal into the granite base. These pins were cored out and the hole was cleaned. Two new notched stainless steel pins were inserted into the hole and set with Wood and Stone KG 321 epoxy. The marble to marble joint was additionally set with Jahn M70 Limestone Standard S1-LS mortar and the marble to granite joint was set with 1-1-6\* mortar. The piece was leveled and made plumb.

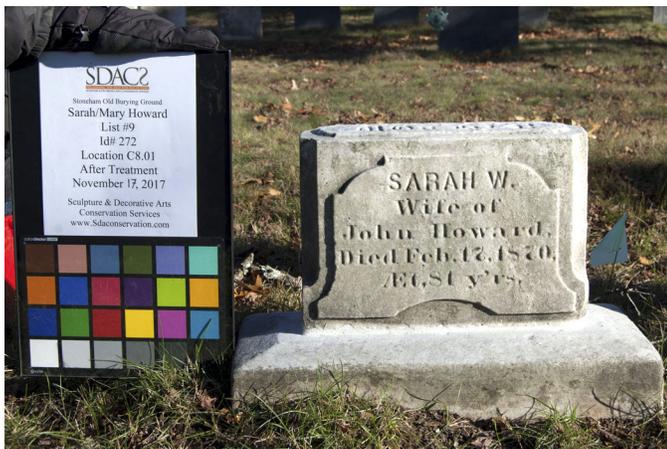
**Image After Treatment**

The marker is loose on its base and needs to be reset.

The surface of the stone is also stained and discolored by lichens and algae.

On separating the top and bottom sections of the markers, two empty holes were revealed. These appear to have previously held iron dowels, now missing. This would substantiate the notion that the piece is a reduced version of the original - cut and reshaped from the original, taller marble gravemarker.

The piece was cleaned with water. A new notched stainless steel pin was inserted into the hole and set with Wood and Stone KG 321 epoxy. The marble to marble join was additionally set with Jahn M70 Limestone Standard S1-LS mortar. The piece was leveled and made plumb.

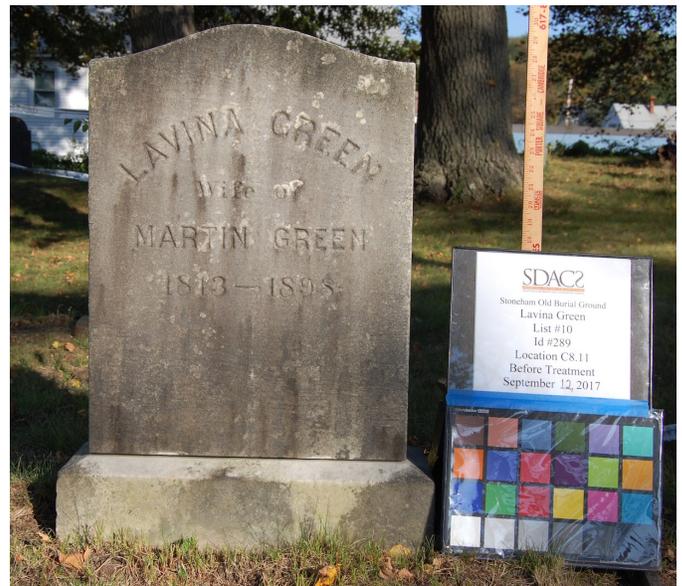
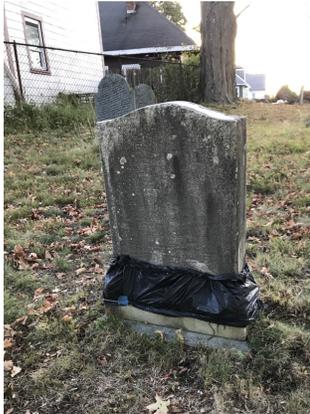
**Image Before Treatment**

The object appears to be kept in place with internal dowels, but it moves from side to side on the pedestal. The piece should be repointed.

The surface of the stone is stained and discolored by lichens and algae.

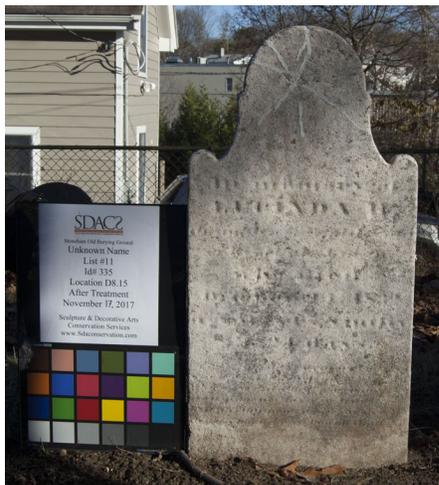
Image After Treatment

The object is in very poor condition. The top is riddled with deep cracks. When the object was excavated, the bottom third was found to have broken off. The surface is very sugary, showing extensive decay and is heavily stained.

The bottom edge of the piece was drilled for two SS 316 3" L x 3/8" Dia threaded dowels. These were set into the marble using a two part epoxy, Akemi Akepox 5010 epoxy. This same epoxy was used to adhere the fragments together and the piece was clamped over the weekend to bring the fragments together tightly.

The piece was reset in 1:2 peastone: stone dust, levelled and made plumb. Soil was added over the bedding material.

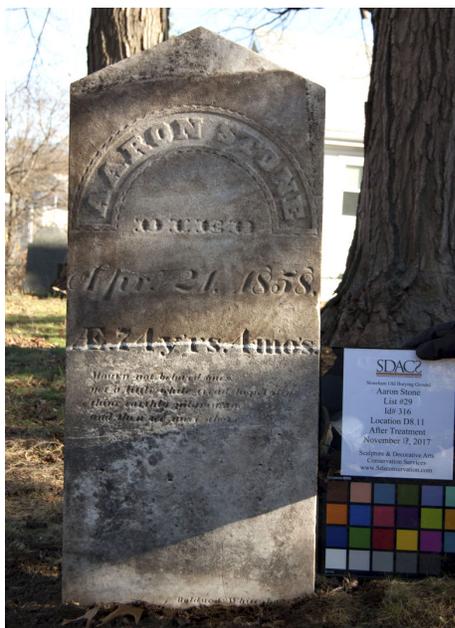
The stone was riddled with cracks and is fragile. The surface is sugary and badly degraded on the back.

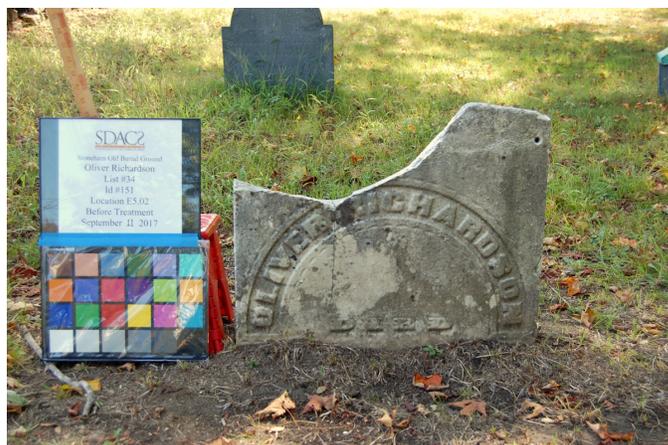
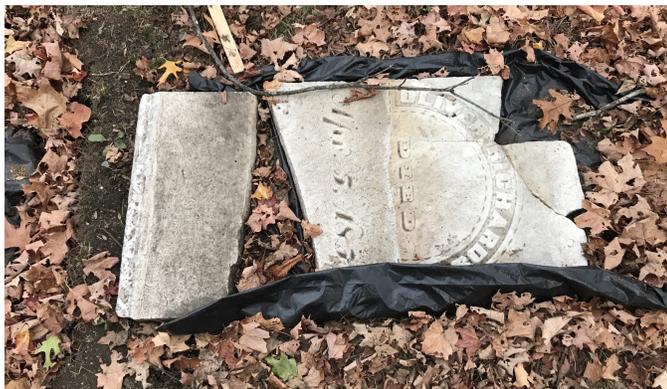
**Image Before Treatment**

The piece is in very poor condition. It is in three major fragments with a large loss at the top of the headstone and with most of the middle section of missing. There are other significant losses as well as many blind cracks and chipped surfaces. The proper left edge shows particularly severe degradation around the back middle area.

The piece has also been significantly stained by contact with the soil and through biological activity.

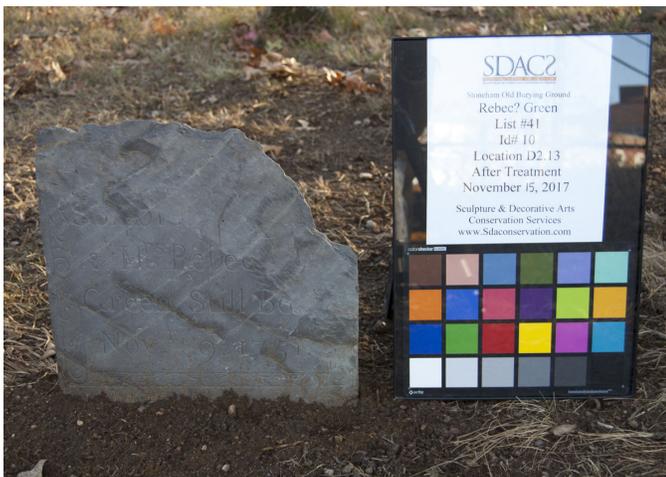
Image After Treatment

The piece is missing a large section of the top of the marker. The greatest loss is along the proper right side and the central section. The proper left still shows evidence of the original shoulder of the carved stone.

The marker was excavated to find any other missing fragments. A number were revealed including three that were part of the original winged skull motif. Unfortunately, so much of the original central section is missing that it was decided not to try and fill the loss. The fragments now remain with the Stoneham Historical Society.

The piece was reset into the a bed of peastone and stone dust 1:2 at the right height and orientation.

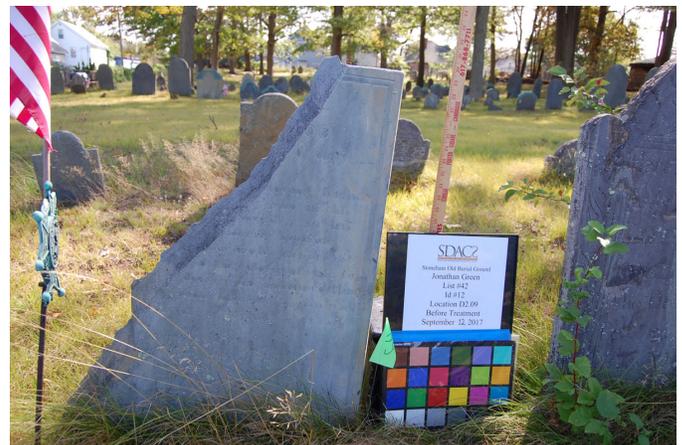
Image Before Treatment

Not treated as the missing fragments were not found.

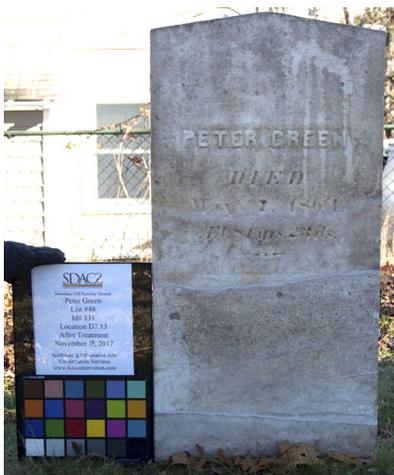
Image After Treatment

The gravemarker was originally surveyed and thought to have a large loss. However, the center fragment was found near a tree nearby. The three fragments fit together well.

The piece is soiled and stained as well. It is set into a slotted base, but this was not excavated as it was level.

The marker was cleaned using the fungicide D2 Biological Solution and rinsed with distilled water. The three fragments were adhered together using Akemi Akepox 5010 epoxy. Gaps were filled using Cathedral Stone's Jahn restoration mortar M70 Limestone Standard S1-LS.

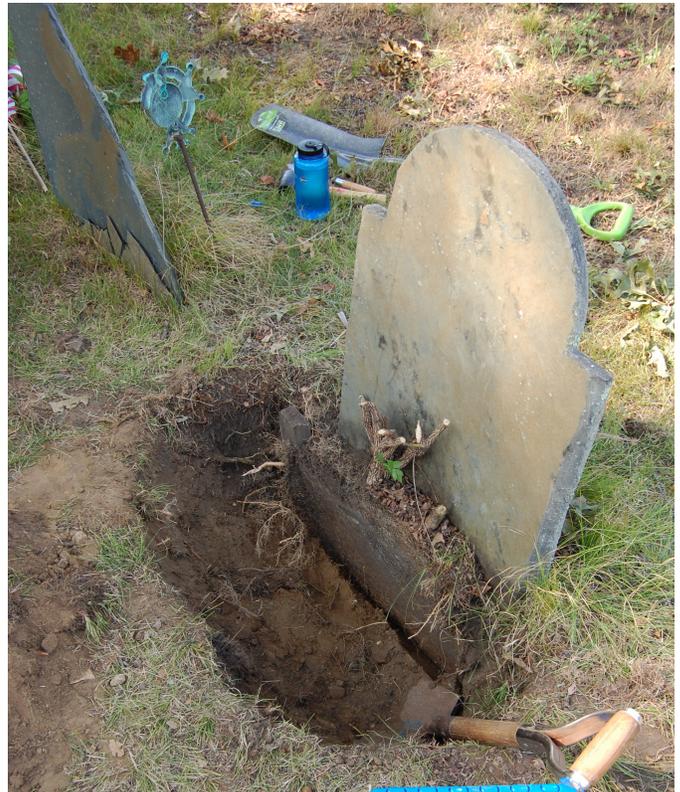
**Image Before Treatment**

This marker was not initially marked as one to conserve. It was thought that the fragment behind it possibly belonged to that of Jonathan Green and therefore it was excavated. This was made more difficult due to a large rooted bush that had taken hold behind the marker. Once the fragment and another fragment were uncovered, it was recognized that they were in fact the bottom section of the marker of Rebekah Green. Moreover, carving of the bottom pieces suggest that the carver had originally started sculpting from this end, but that the stone may have broken along a fault line. It appears that he or she may have then turned the stone around and carved the other end instead.
